PREFACE

Considerable information on flood proofing exists. This information is generally in the form of brochures, booklets, or reports describing the various flood proofing measures, where the measures should be used, and how to design flood proofed structures. The U.S. Army Corps of Engineers' National Flood Proofing Committee (NFPC) has recognized the need for information that describes how flood proofing measures perform when they are actually tested by floodwater. The NFPC originally solicited such information from Federal and State agencies and other organizations; however, the request resulted in little information. As a result, the NFPC acquired information by visiting various selected flooded areas across the United States. Flood proofed structures located within those flooded areas were inspected to determine the performance of flood proofing measures. The NFPC documented the results of its information-gathering effort into this report, which describes actual flood proofed structures and how floodwater affected those structures. With each specific case described, a "lesson" is presented to briefly describe what worked and what did not.

Data on 12 floods were collected.

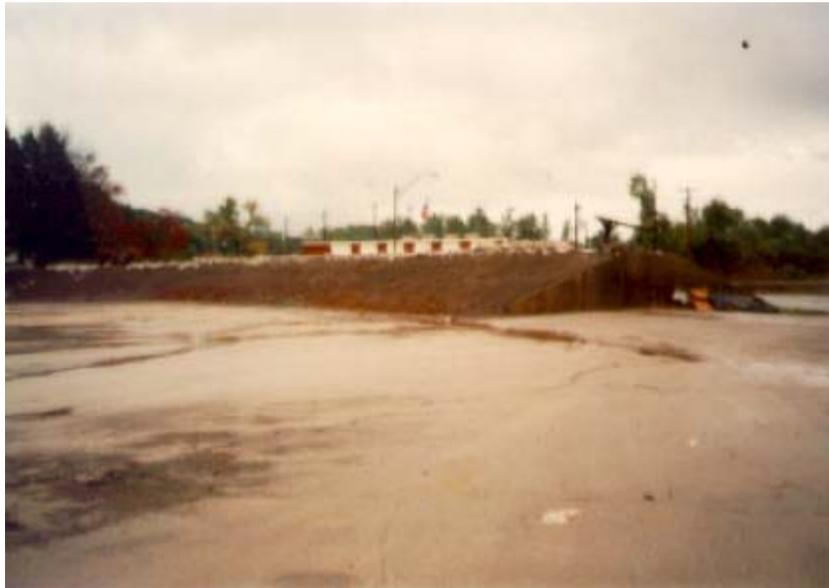
Lesson. In this case, all parts of the flood proofing system functioned as intended except that the levee was overtopped, leading to levee breaching. Obviously, the levee should have been higher for this event. The levee failed where the sideslopes were 1 vertical to 1 horizontal. Levee breaching may not have occurred if flatter sideslopes (1 vertical to 3 horizontal or flatter) had been used. Sideslopes of 1 vertical to 1 horizontal are without question too steep for reliable levee stability. Without levee breaching, a successful flood fight may have been possible. This flood proofing system had a definite weak point -- that portion of the levee with the 1 vertical to 1 horizontal sideslopes. If not enough area was present for a levee with flatter sideslopes, a floodwall should have been built in that location.

Looking at the portion of the partial ring levee with flatter sideslopes. Note the opening that was closed with a closure structure that was successful. Note the sandbag flood fight on top of the levee.

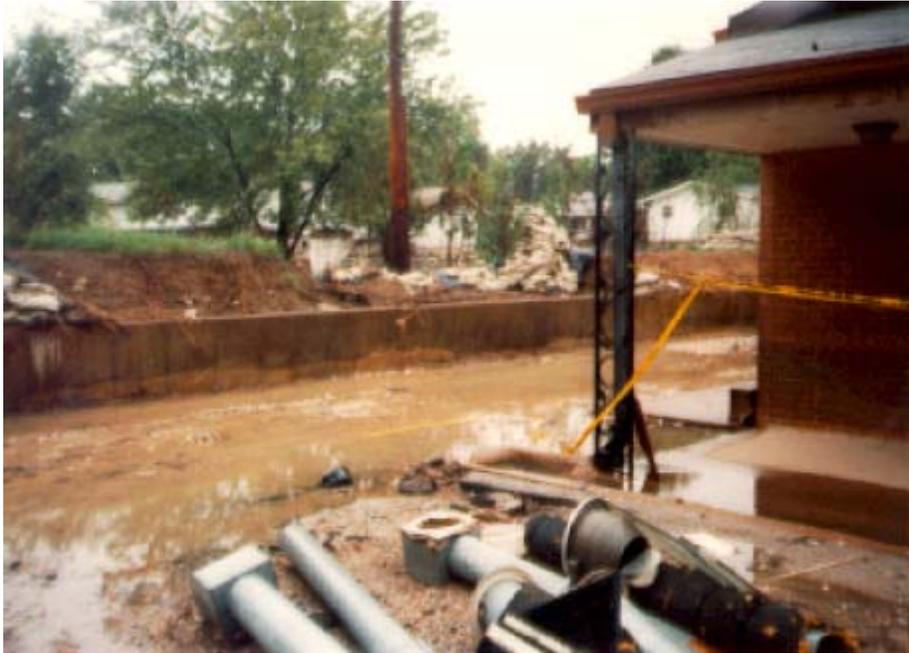
Looking at the portion of the partial ring levee with steep sideslopes that resulted in complete failure due to breaching.

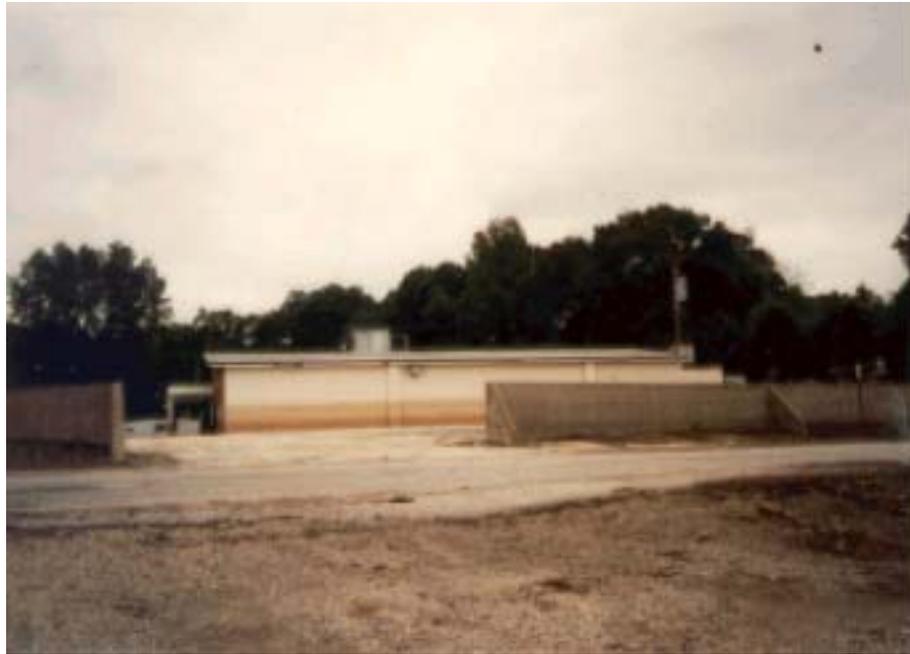
Lesson. This system apparently worked well until it was overtopped. Floodwall bracing, if placed on the “dry” side of the wall, would provide more reliable support in a compression rather than tension mode. In regard to the wall being overtopped, a 9-foot-high wall (to eliminate overtopping in this event) probably would have been more expensive than relocating the mobile homes and two permanent buildings. Relocation out of flood-prone areas is the ultimate in flood proofing. Conducting a flood fight by raising the wall with temporary “flashboards” made of supported plywood may have been possible, although a 3-foot extension on a 6-foot wall would probably have reached the upper limits of reliability.

Looking at the floodwall and also the building on the “protected” side. Note the bracing on the “wet” side of the floodwall.

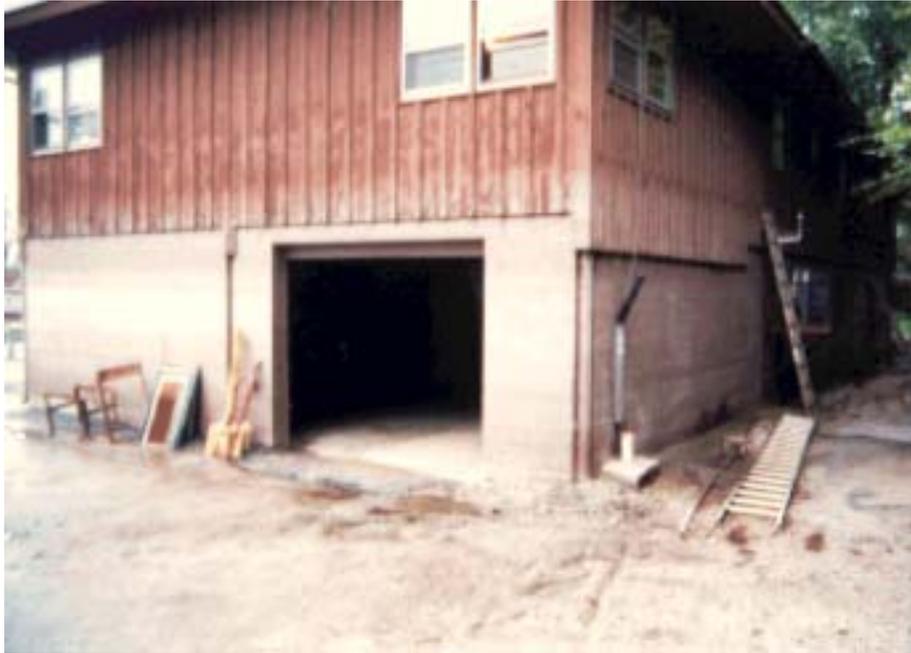
Lesson. The only factor that separated a successful system from a failed system was whether or not the home was elevated so the first floor elevation was higher than the flood elevation. The type of support (posts (columns), piles, piers, or extended foundation walls) and the number, size, and composition of the supports (steel, wood, or concrete block) did not matter relative to the success of the flood proofing system. Bracing the supports also was not a factor relative to low-velocity floodwater. Bracing would be a factor, as would support size, type, and number and also the elevation measure used, for those elevated structures that could be affected by wind and hydrodynamic force. The real lesson is to always elevate as high as possible without becoming so high that mitigating wind and/or seismic forces becomes so costly compared to mitigating flood forces only that relocation becomes most feasible.

Looking at a typical structure elevated on extended foundation walls. Flood depth was about one foot above the main (elevated) floor. Note the elevated utilities on the outside wall.

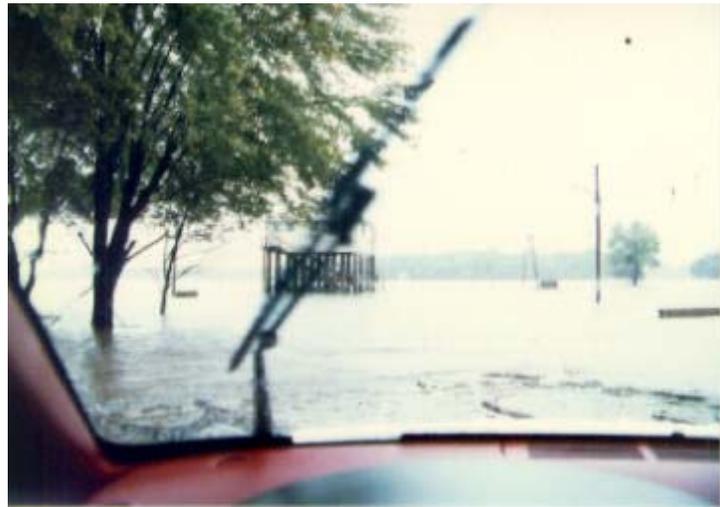
Looking at a typical structure elevated on masonry columns with bracing. The structure is nontypical because it was the only elevated structure viewed that was above the flood.

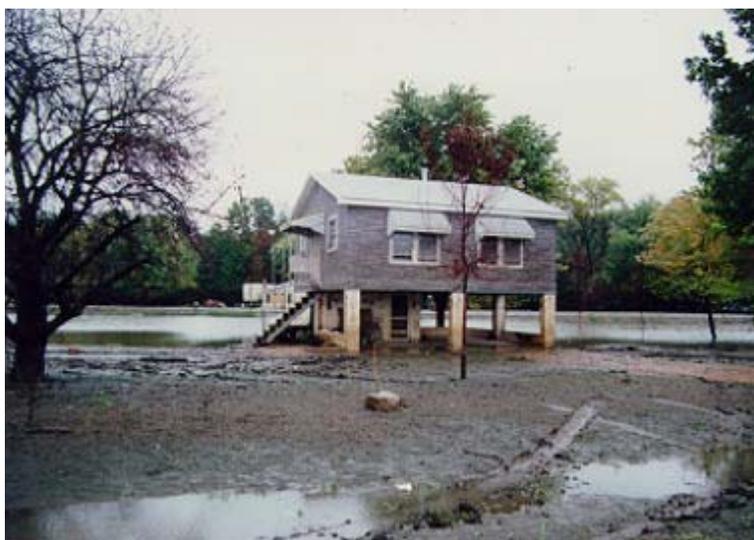
Looking at a typical structure elevated on masonry columns that had water above the main (elevated) floor.

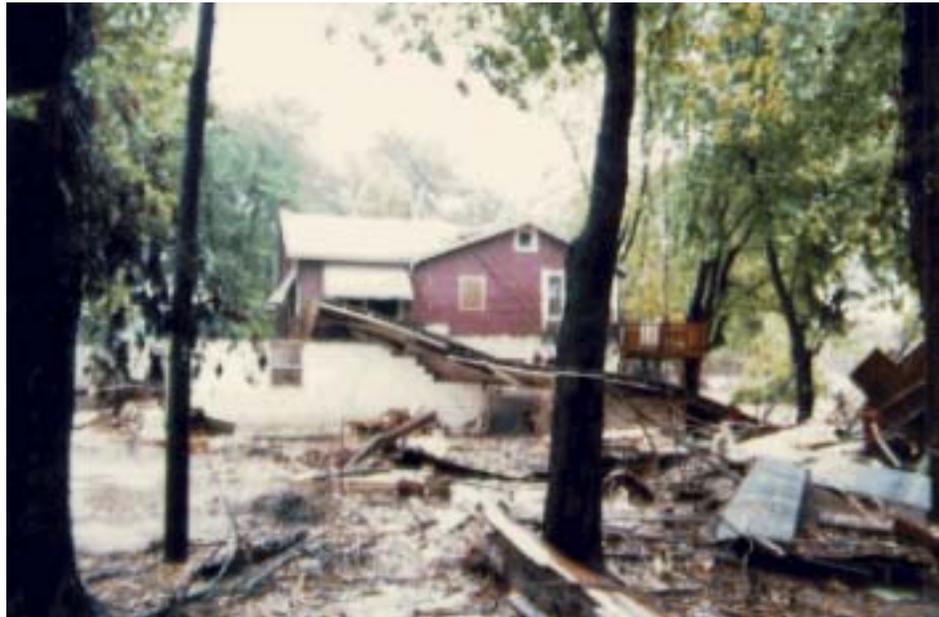
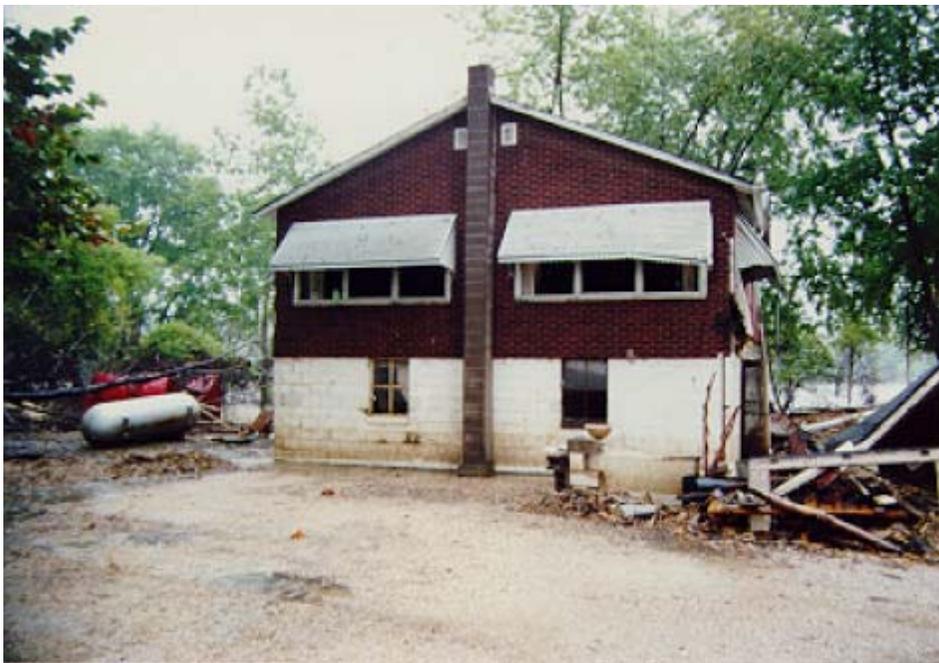
Looking at Structures 52 and 53.

four structures, the extended concrete block wall to support the structure should not have been used in an area close to a major river where high velocity during floodflows could occur. Supports such as columns, posts, or piles embedded sufficiently below grade should have been used, with piles being the preferred choice. Any enclosure of the lower area should have been of minimal strength to easily break under hydrdynamic force.

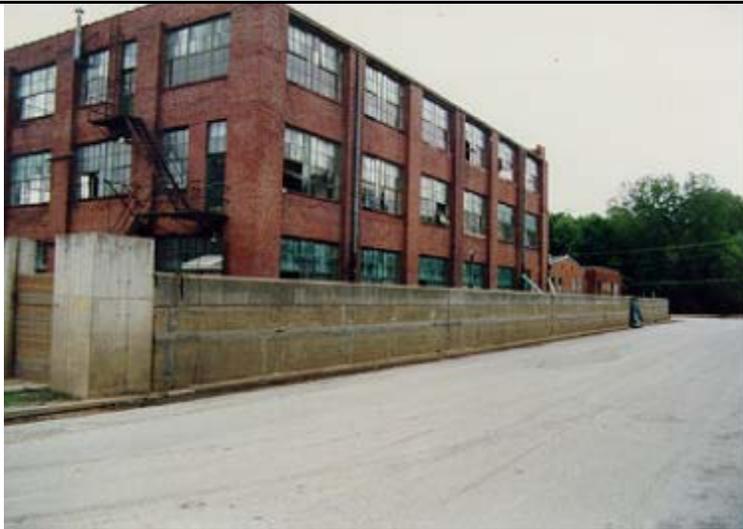
Lesson. About 150 feet of the wall collapsed at the seam between the original wall and the first 2-foot extension. Of the 150-foot section that failed, a 90-foot section had foundation failure. Both failures occurred because (1) the original wall footing was not designed for extensions doubling the original wall height and (2) the assumption that rebar tied the first extension to the original wall was false. Upon wall failure and due in part to the close proximity of the wall to the building, the building roof subsequently failed. After the flood, the building was being abandoned and the industry was relocating to a flood-free site.

Looking at the floodwall. Note the closures at left and far right, the original floodwall, and the two additions. The failed portion is between the building and the trees in the background.

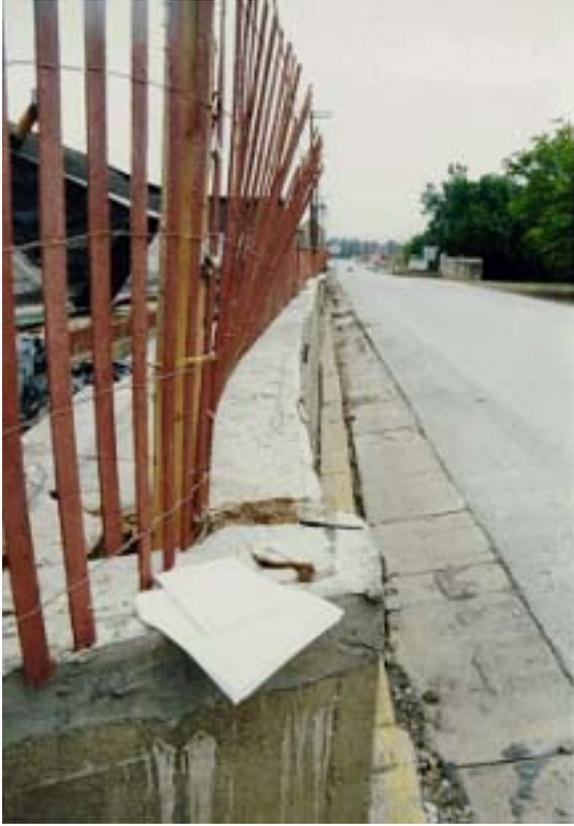
Looking at the original floodwall. Note the foundation failure resulting in wall misalignment. Also, note the absence of rebar on the original floodwall.

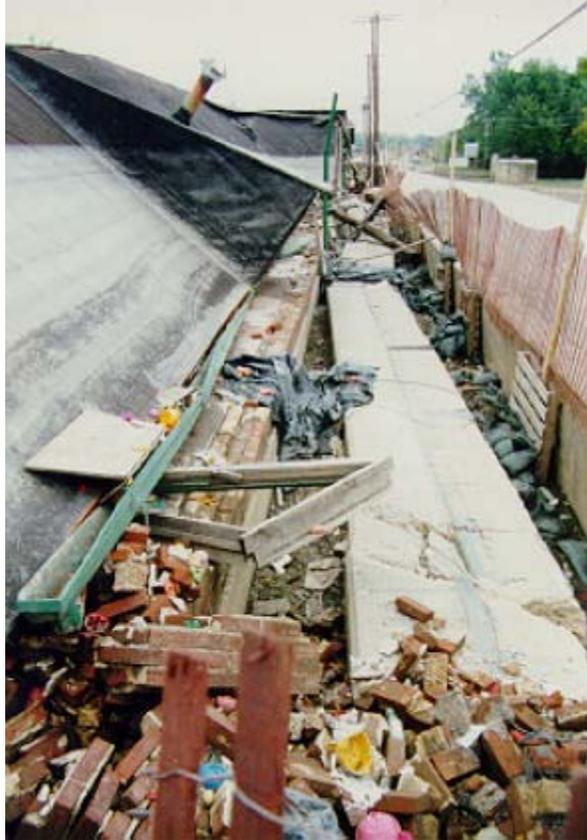
Looking at the collapsed floodwall additions. Note these two additions are still tied together with rebar.

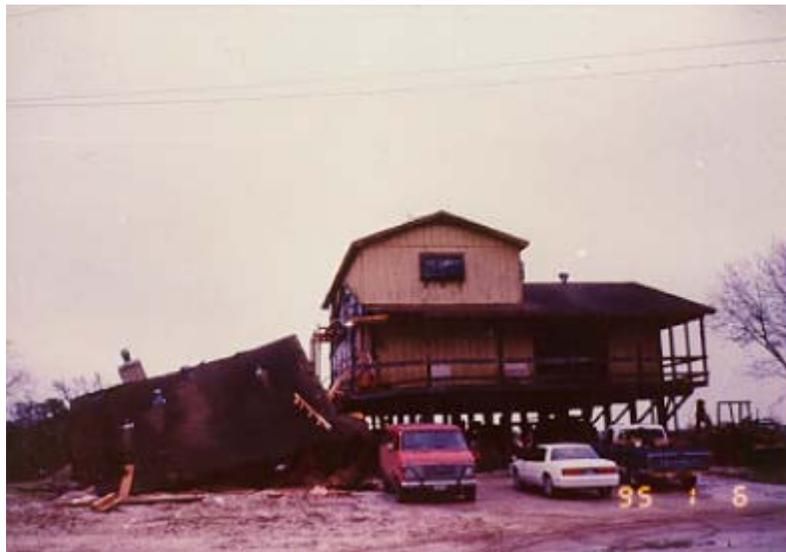
Lesson. This structure was exposed to extreme high velocities. Structure failure occurred because of four basic reasons. First, the enclosed lower area utility room created even higher localized velocities than already present as the floodwater flowed around the obstruction. Second, the enclosed area was near the "upstream" corner of the structure so the localized velocity increase occurred near the slab edge where scour could occur beneath the slab. Third, perimeter footings were not in place under the slab-on-grade to prevent scour beneath the slab. Fourth, the post embedment depth was not deeper than the scour depth. These factors combined to create a situation conducive to massive scour and failure. The eastern portion of the structure, which did not have an enclosed area, functioned successfully.

Looking at the collapsed portion of the structure. The collapsed portion is at the left.
The river is behind the structure

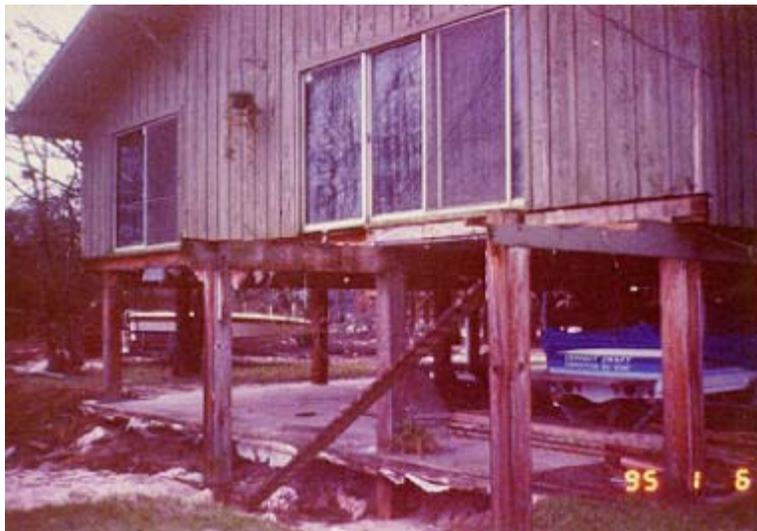
Lesson. This flood proofing system functioned very well. This appears to be due to the lack of a localized velocity-increasing mechanism, such as a lower enclosed area, that would create a situation conducive to large amounts of scour. This structure should be retrofitted with perimeter footings around the slab-on-grade embedded to below scour depth to prevent the amount of scour that did occur.

Looking away from the river at the structure. Note the area beneath the structure is completely open.

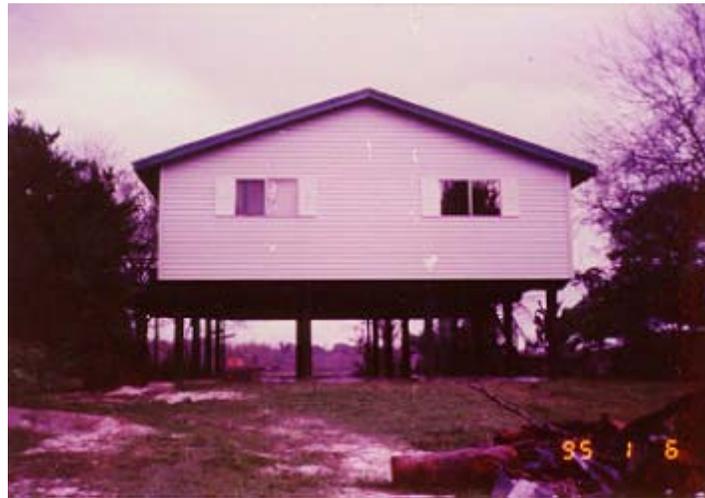
Lesson. This flood proofing system worked well. No scour was evident, probably because of the "shield" effect of a row of trees and brush to the left (upstream) side of the structure. These trees apparently provided protection from the high velocities so scour did not attack even the slab-on-grade. The lack of an enclosed obstruction in the lower area prevented the creation of high localized scour-producing velocities. Scour was evident to the left of the row of trees.

Looking toward the river at the structure. Note the trees on the left that apparently protect this structure.
Note, also the lack of any obstruction beneath the structure.

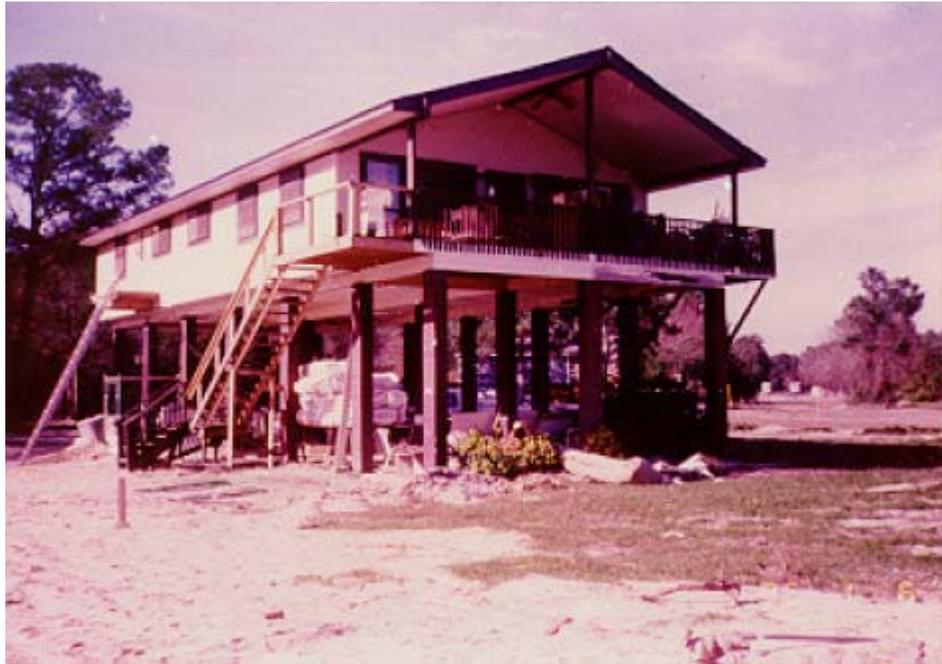
Lesson. This structure received relatively little flood-related damage during this event. The home was realigned and the scoured area filled. Even with this "success," this flood proofing system should not be promoted. The risk to this structure is great for two reasons--both related to debris accumulation. First, severe debris accumulation, coupled with hydrodynamic force, could tip over the structure. Second, scour could severely undermine this structure's foundation because of debris accumulation, also resulting in the structure tipping.

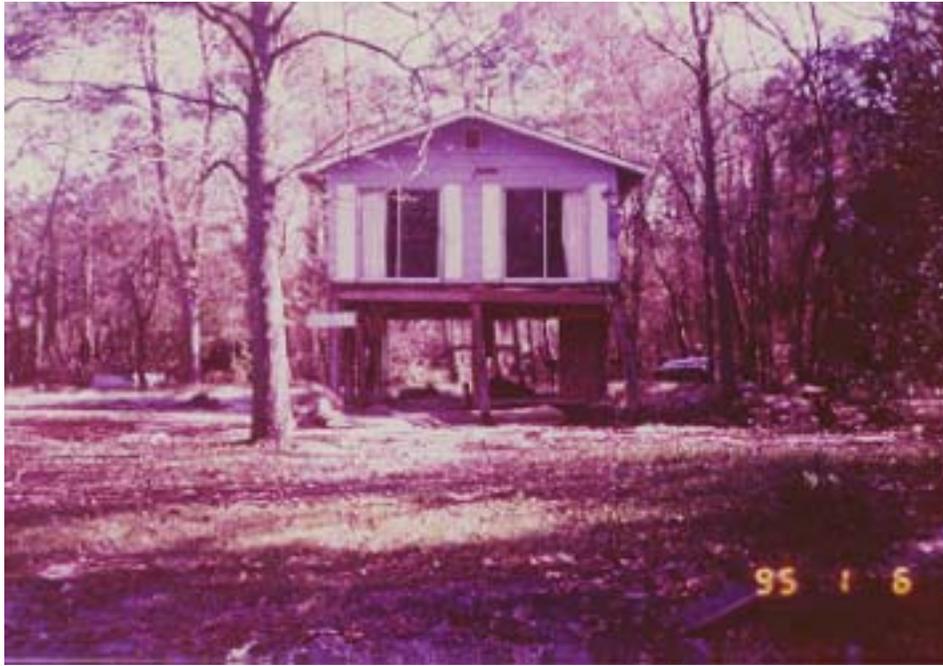
Lesson. Damage occurred with this system because of the enclosed lower area, which created high localized velocities and scour, and the extremely shallow post embedment depth. If the posts had been embedded to a greater depth and placed in concrete and the enclosed area had not been present, this structure would probably have sustained no damage.

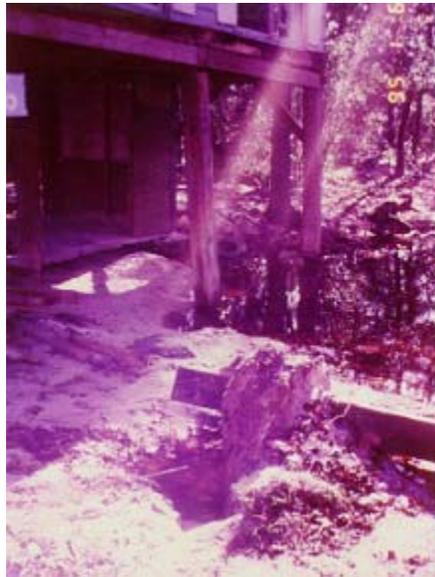
Looking at the structure's shallow post embedment depth.

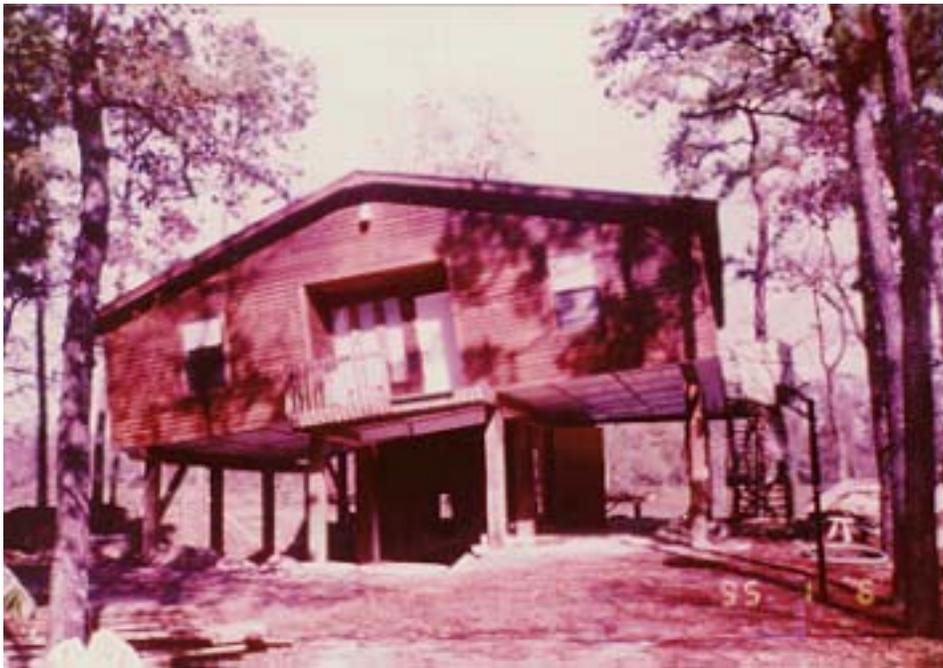
Lesson. This structure had an enclosed area in the central portion of the lower area between the slab-on-grade and the first floor of the home. This enclosed area was conducive to creating high localized velocities. Its location, however, in the central part of the lower area surrounded by a concrete slab for some distance proved in other structures to be not nearly as damaging due to scour as when located near the upstream edge of the slab. Apparently, the tremendous scour that occurred at this structure was aggravated by the enclosed area but was created mostly by the structure's location along the river. Perimeter footings under the slab-on-grade would have greatly reduced the scour even in this apparently bad location. Post embedment depth obviously should have been deeper. For definite protection from this type of damage, piles driven to below the scour depth would have been the ultimate solution.

Looking at tilted structure as a result of scour under the left portion of the structure.

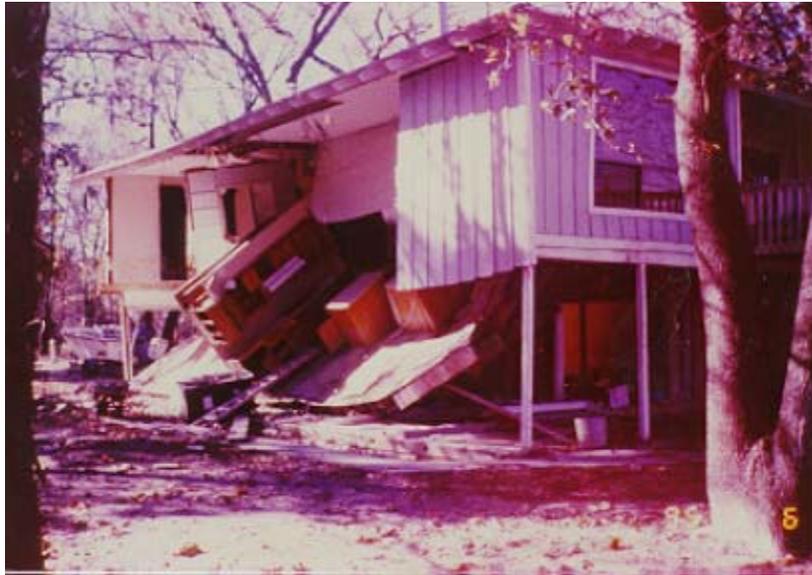
Lesson. This flood proofing system failed for basically two reasons. First, the lower area was completely finished, creating high localized velocities that resulted in extensive damage to the interior. Second, extended foundation walls were used, inappropriately, in high-velocity areas, subjecting the structure to hydrodynamic force.

Looking at the failed structure.

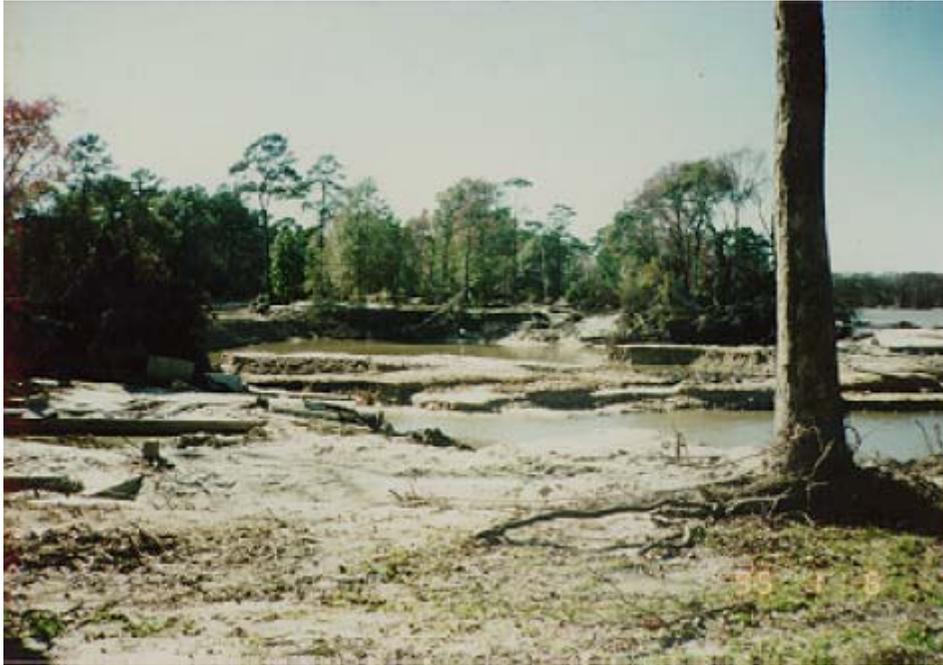
Lesson. No flood proofing system can withstand erosion such as that experienced here. Construction of any type in an area where extremely high velocities can occur is not advised and reflects extremely poor judgment.

Looking across the area previously occupied by these structures.

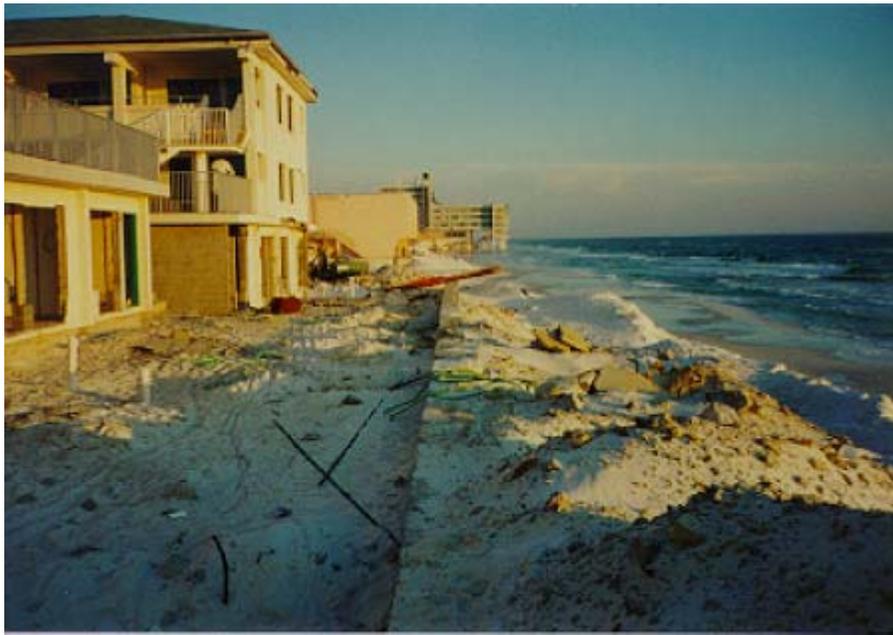
Lesson. Slab-on-grade construction with shallow footings should not have been used in this location because of the enormous potential for scour. The lower floor should not have been developed because of the great potential for flooding from hurricane force wave runup. These structures, as built, were saved from major structural damage by basically two items. One, the presence of the large plate glass windows on the lower floor broke under wave force, allowing flood damage to occur but reducing the potential for complete wall failure due to hydrodynamic force. Two, the presence of the seawall protected the slab-on-grade foundation from extensive scour, which would have allowed substantial structural failure to occur.

Looking at the slab-on-ground structures and the seawall.

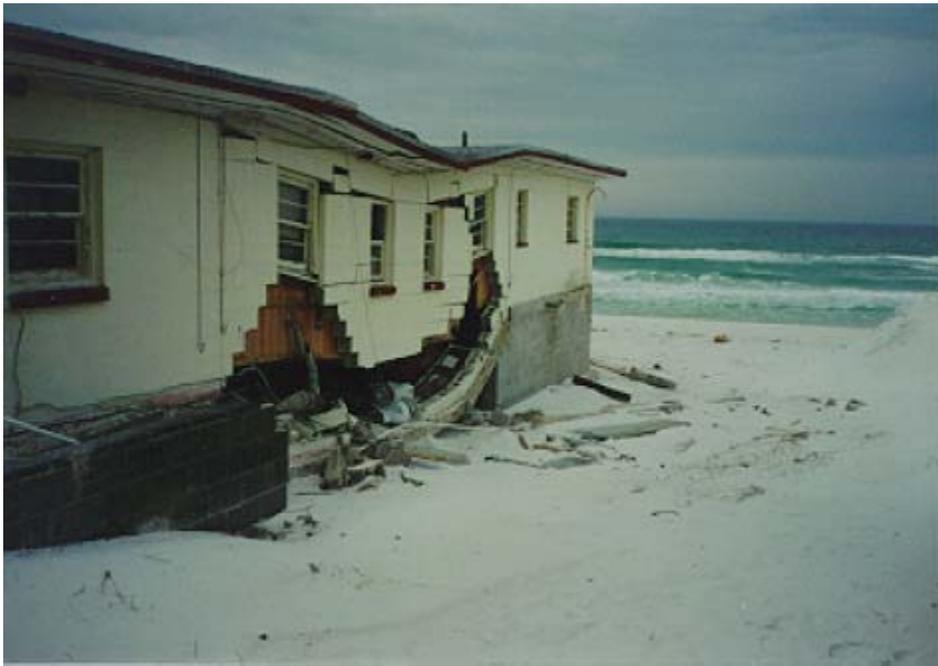
Lesson. Four basic problems were present with this structure. First, the footings were too shallow, allowing scour to undermine them. Second, extended foundation walls, which are not appropriate for coastal areas subject to hydrodynamic force, were used. In this particular case, failure did not occur because of extended walls, but they made the structure highly susceptible. Third, the concrete slab for the first floor was supported by sandfill. When the perimeter wall failed, erosion of the sandfill occurred, causing the floor to collapse. The floor should have been supported on piles driven to a depth below the potential scour, or the perimeter footings supporting the extended foundation walls should have been constructed to below-scour depth. Fourth, the structure was not elevated enough to prevent floodwater damage. Structures such as this in this location need to be elevated on piles.

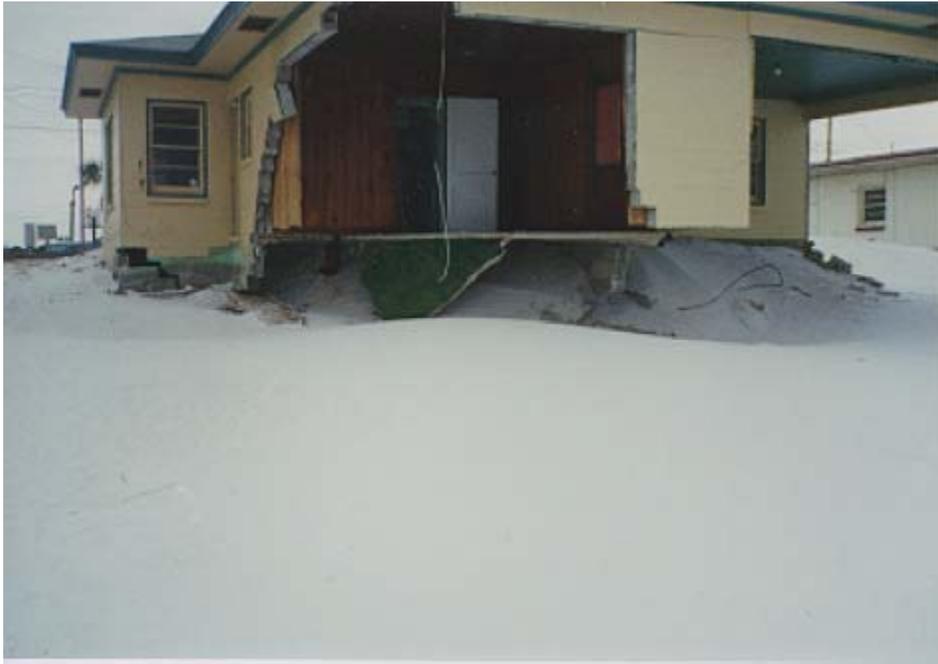
Lesson. This structure had the same basic four problems as Structure 74--shallow footings, extended foundation walls, concrete slab on sandfill, and inadequate structure elevation. Extended foundation wall failure was due first to scour and then to hydrodynamic force. The roofline on this structure was maintained, unlike that on Structure 74, probably because of the presence (in the middle of the structure) of the concrete block support for the floor and interior wall. This example shows the importance of multiple supports beneath a structure in an area subject to excessive scour. As stated for Structure 74, a structure with extended foundation walls, shallow footings, and a concrete slab on sandfill is definitely not appropriate at this location.

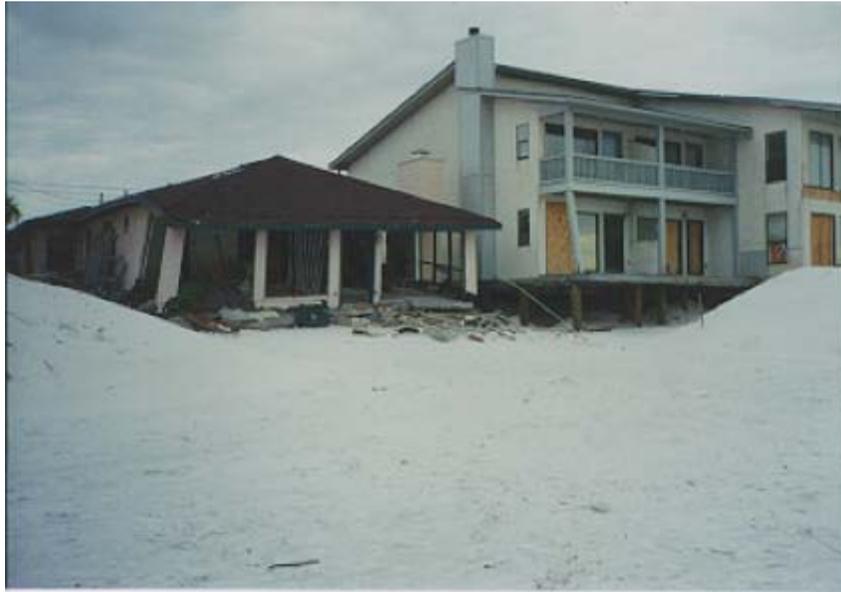
Lesson. Comparing Structures 77 and 78, located adjacent to one another, shows the inherent problem with shallow footings, extended foundation walls, and a first-floor concrete slab supported by sandfill. Scour undermined the shallow footings of Structure 77, causing, with hydrodynamic force, the failure of the extended wall foundations. This allowed erosion of the sandfill supporting the first-floor concrete slab and failure. In contrast, Structure 78, supported on piles embedded below scour depth, sustained no structural damage. Both structures were flooded because of inadequate elevation.

Looking at the structure with extended foundation walls on the left and at the structure with a pile support foundation on the right.

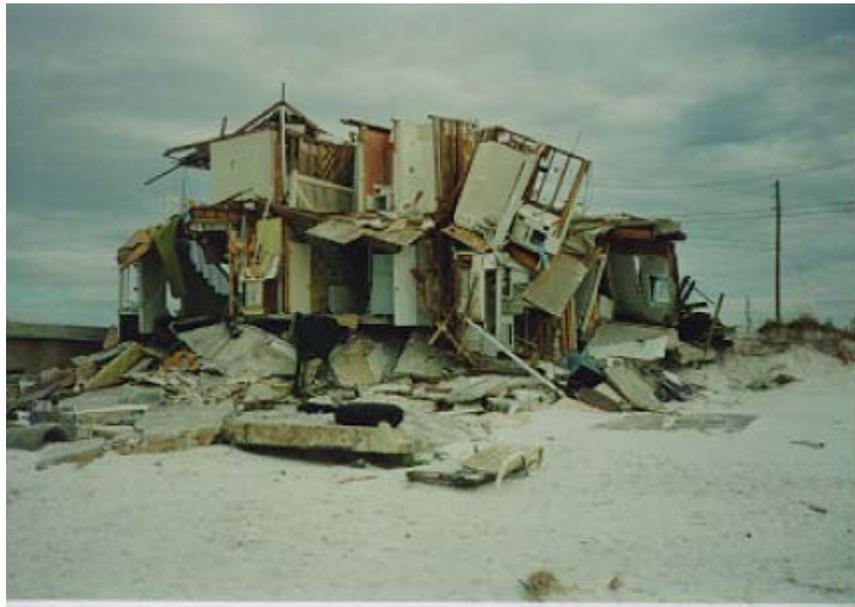
Lesson. This structure is discussed because it sustained massive damage even though it was elevated as much or more than most structures along this reach of beachfront. Failure probably started to occur because of scour beneath the shallow footings and hydrodynamic force against the extended foundation walls and the structure itself. Erosion of the sandfill caused concrete slab failure. Failure of these foundation elements substantially weakened the structural integrity of the wood-frame structure, allowing wind and hydrodynamic force to cause a near total destruction. A foundation of piles embedded below scour depth, with the piles extending to the roofline for proper structure/footing tie-in, and hurricane fasteners would probably have allowed this structure to sustain minimal damage.

Looking at the totally failed structure from the beach.

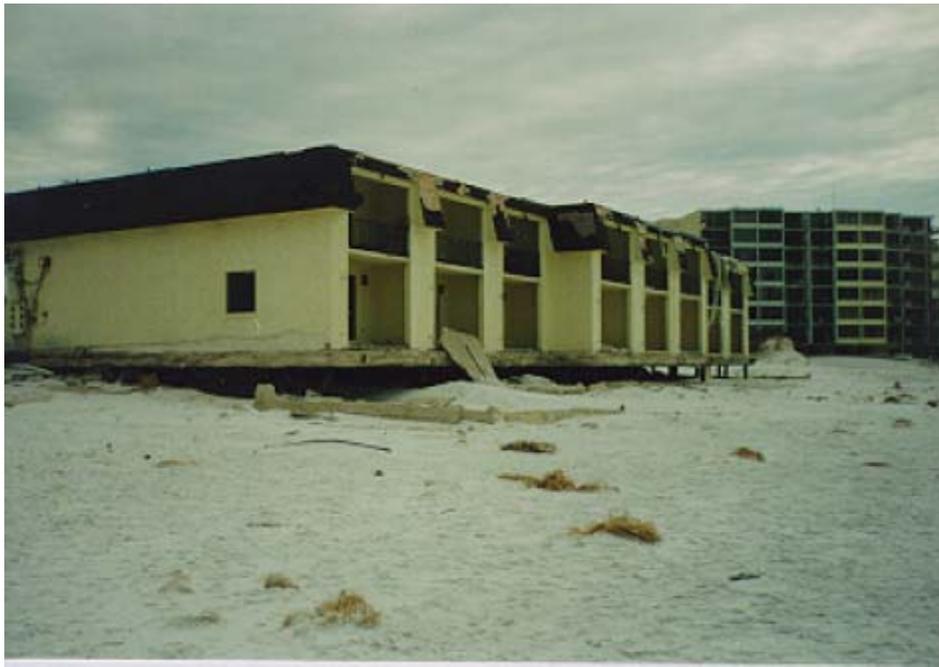
Lesson. The structure performed adequately except for two reasons. One, the structure was not elevated high enough to prevent flooding. Two, the concrete slab on the first floor was supported only by sandfill. When the sand eroded, the floor collapsed. Floor collapse could have been prevented by placing supporting posts beneath the concrete slab or by using rebar to support the floor from the piles located beneath the bearing walls.

Looking at the structure. Note that the building structure did not collapse due to the pile support foundation.

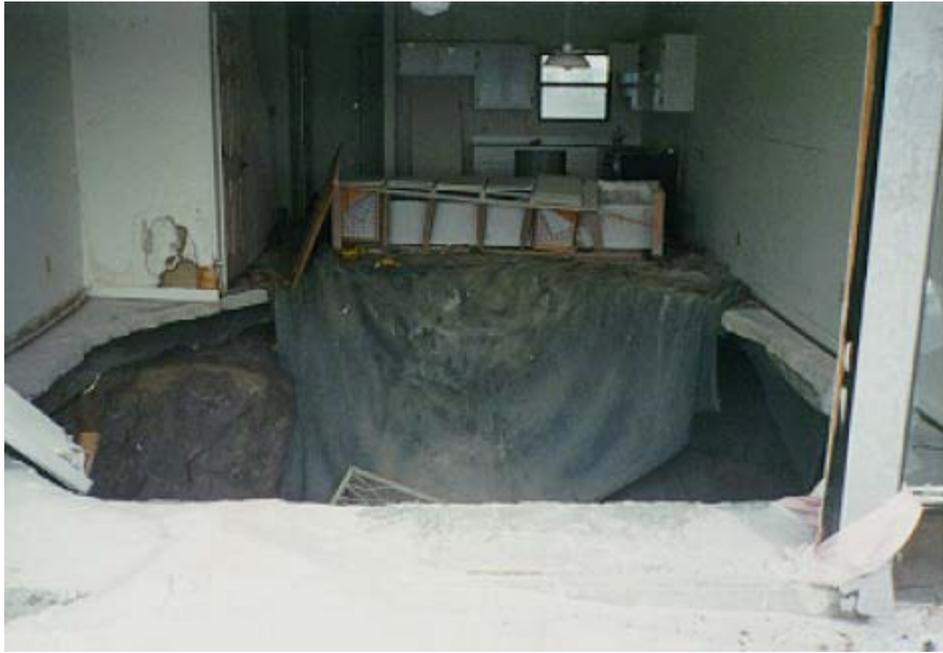
Looking inside the structure at the collapsed floor due to scour of the sand beneath the slab-on-grade floor

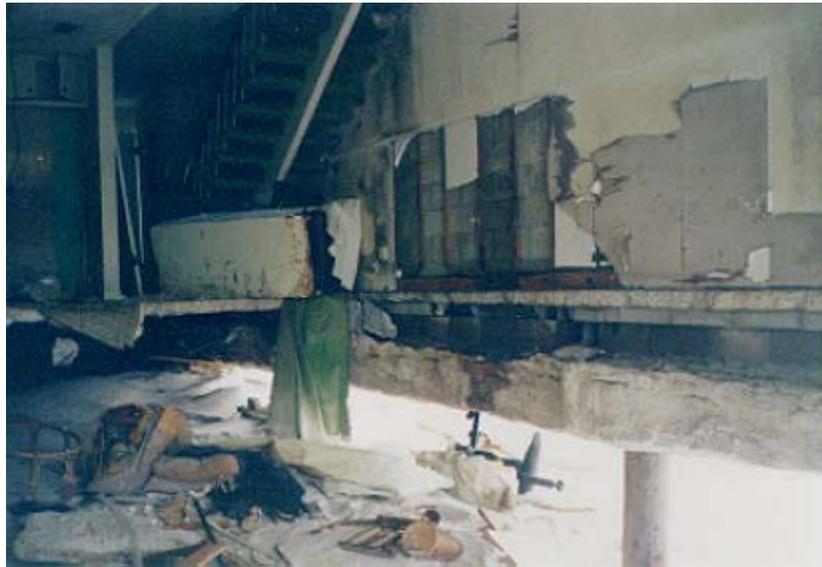
Looking inside the structure at the collapsed floor due to scour of the sand beneath the slab-on-grade floor.

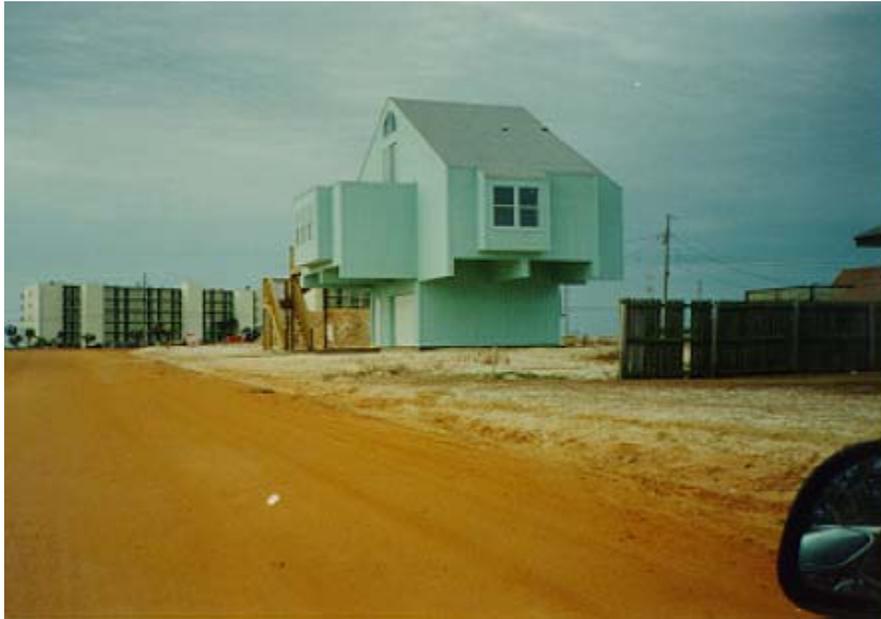
Lesson. This structure was recently constructed. It had adequate elevation and was constructed to state-of-the-art building codes. Because of its location two blocks from the beach and behind a large multistory building that may have provided some protection from hydrodynamic force, the degree of hazard was lower than had it been located directly on the beach. A note of caution with this structure is the enclosed lower area. This type of enclosed construction, unless the walls are able to break away during a hurricane event, subjects the structure to hydrodynamic force and the potential for foundation scour due to the obstruction to waterflow caused by the enclosed walls at ground level.

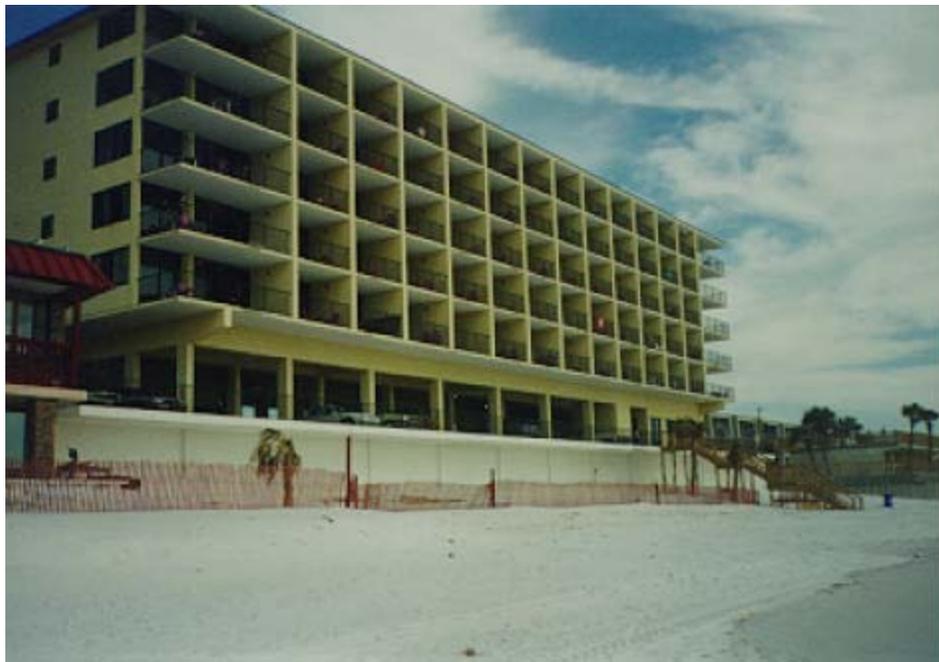
Lesson. This structure was successful for two basic reasons. It had both proper elevation and proper scour/erosion protection. The first damageable floor was well above the flood level since it was two floors above the ocean level. The first floor was occupied by automobiles which can easily be moved to a nonhazard area with proper warning time. Scour did not pose a problem because of the wall and the proper column embedment depth.

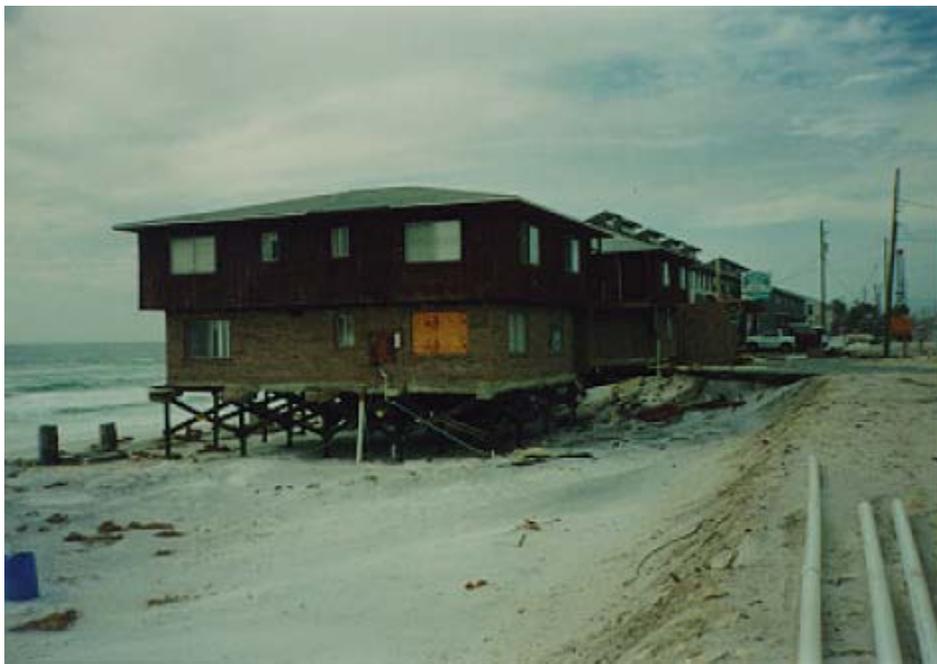
Lesson. Severe scour occurred around and under these structures during the event. The wood piles appeared to be improperly sized, since some were visibly leaning under the weight of the buildings without sandfill support. The “x” bracing on the piles may have saved the building from collapsing. This shows the need not only for proper embedment depth of posts or piles but also for proper size of posts or piles for needed strength. In this case, where sandfill appears to have been factored in as a part of the building support/stability system, a protection wall around the building that could have withstood the scour hazard and hydrodynamic force should have been built. The most proper design, however, would have been to elevate the buildings on larger diameter piles that were completely independent of sandfill for added support to the buildings.

Looking at the structure and beach. Prior to the event, the “grade” elevation at the far right extended toward the beach and under the structure.

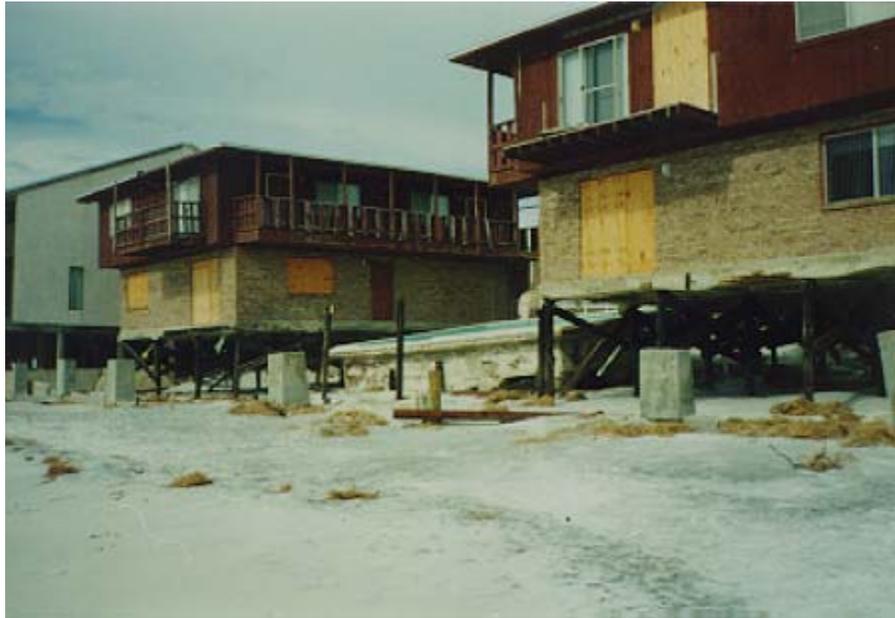
Looking from the beach at the structure. Note the collapsed swimming pool between the structures.

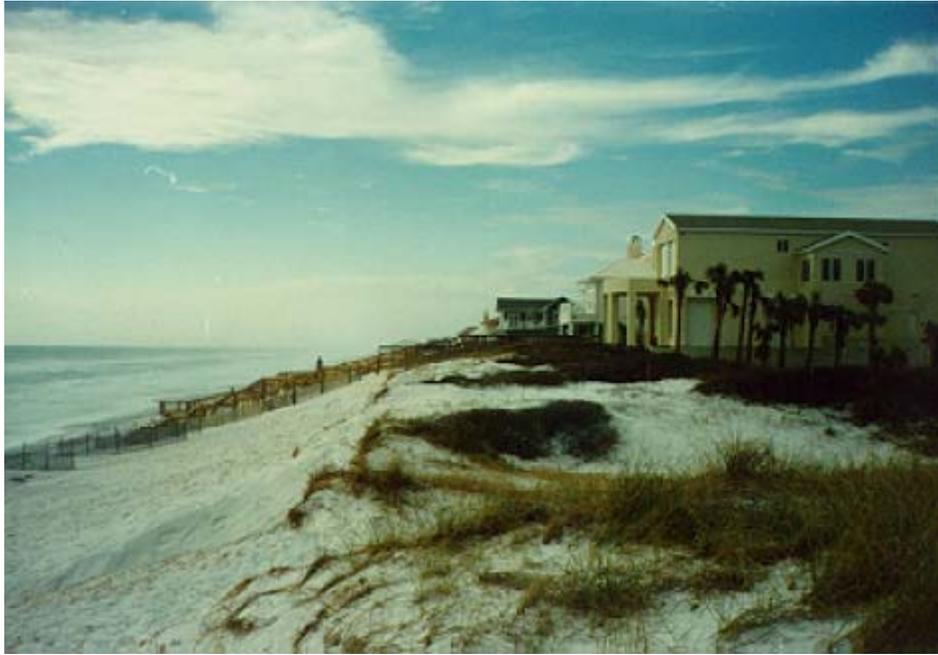
Lesson. “Conventional” construction techniques in the structure itself are often very adequate to mitigate hazards from floods, erosion, and hydrodynamic force if other nonstructure-related techniques are employed. In this case, constructing structures on higher ground is a large step toward hazard mitigation in the form of reduced flood damages. A large setback allows room for either a natural or a manmade dune to be located between the ocean and the structure. This can diminish or eliminate hydrodynamic force on the structure and the potential for scour at the structure.

Looking along the beach at the structure and the dune. Note the structure elevation and the dune protection.
