PREFACE

Considerable information on flood proofing exists. This information is generally in the form of brochures, booklets, or reports describing the various flood proofing measures, where the measures should be used, and how to design flood proofed structures. The U.S. Army Corps of Engineers' National Flood Proofing Committee (NFPC) has recognized the need for information that describes how flood proofing measures perform when they are actually tested by floodwater. The NFPC originally solicited such information from Federal and State agencies and other organizations; however, the request resulted in little information. As a result, the NFPC acquired information by visiting various selected flooded areas across the United States. Flood proofed structures located within those flooded areas were inspected to determine the performance of flood proofing measures. The NFPC documented the results of its information-gathering effort into this report, which describes actual flood proofed structures and how floodwater affected those structures. With each specific case described, a "lesson" is presented to briefly describe what worked and what did not.

Data on 12 floods were collected.

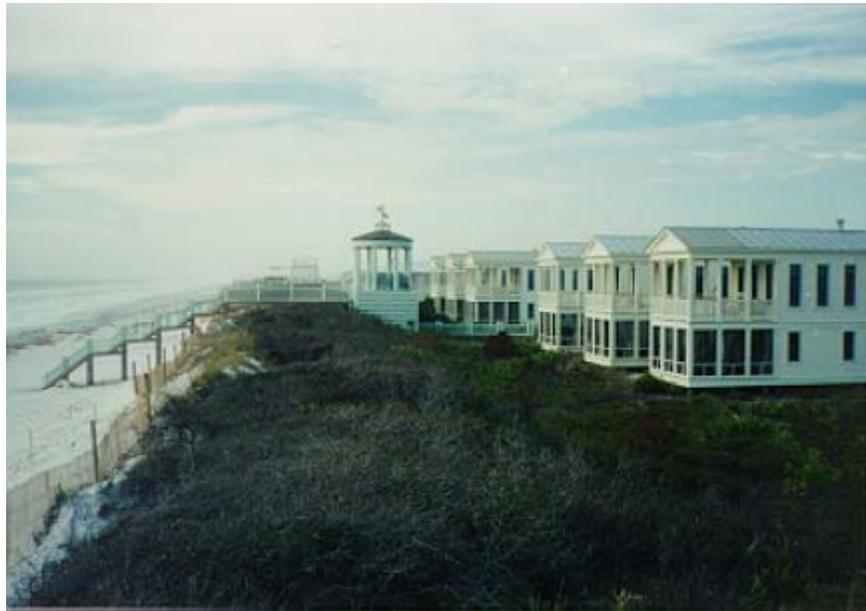
Looking along the beach at the structures and the dune. Note these structures are not elevated as high as those in the above photograph but the dune has much more vegetation.

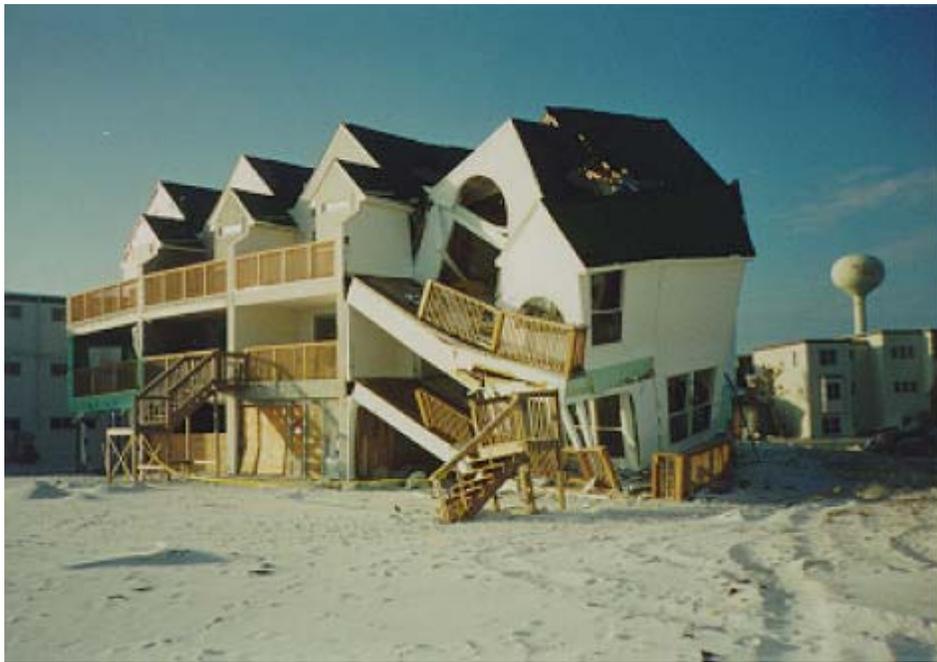
Lesson. Two basic factors caused the collapse of one-fourth of the structure. First, the construction on the barrier island placed the structure in jeopardy due to high-velocity floodwater, creating both a hydrodynamic force hazard and a scour hazard. Construction in areas such as this should be avoided. Second, the structure foundation that was situated in sand should have been much deeper to resist the forces of erosion caused by the high velocities and compounded by the obstructive nature of the structure.

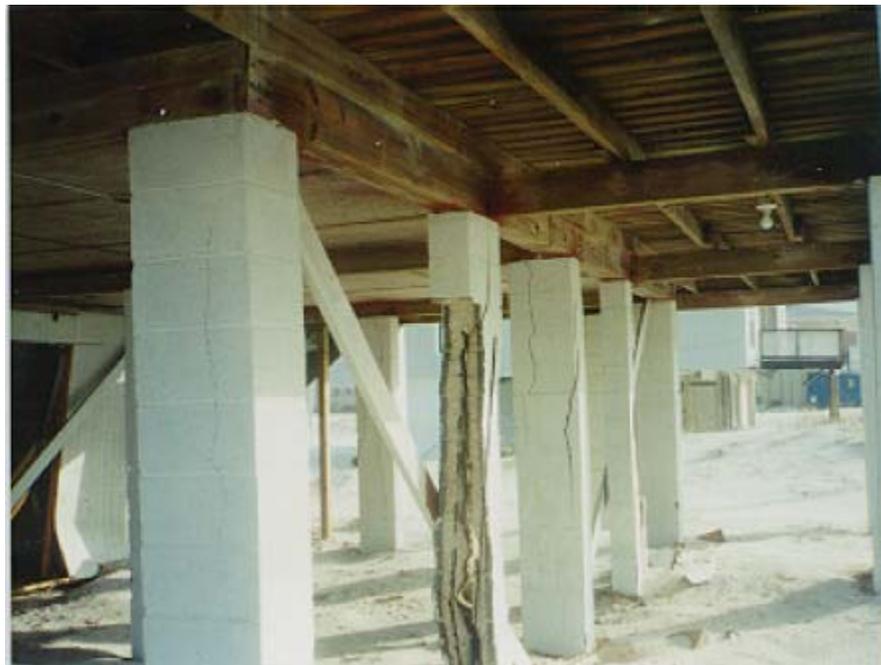
Looking at the column support that was nearing failure.

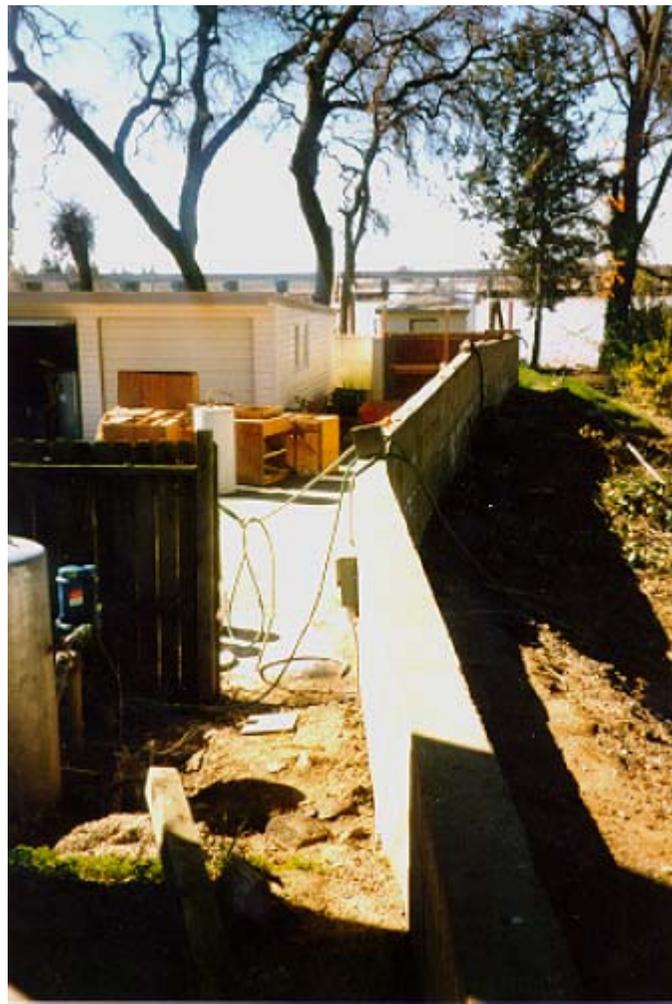
Looking along a portion of the floodwall. The failure under the wall occurred in the immediate foreground. Note the largest closure at the right of the structure. Also note the Sacramento River in the background.

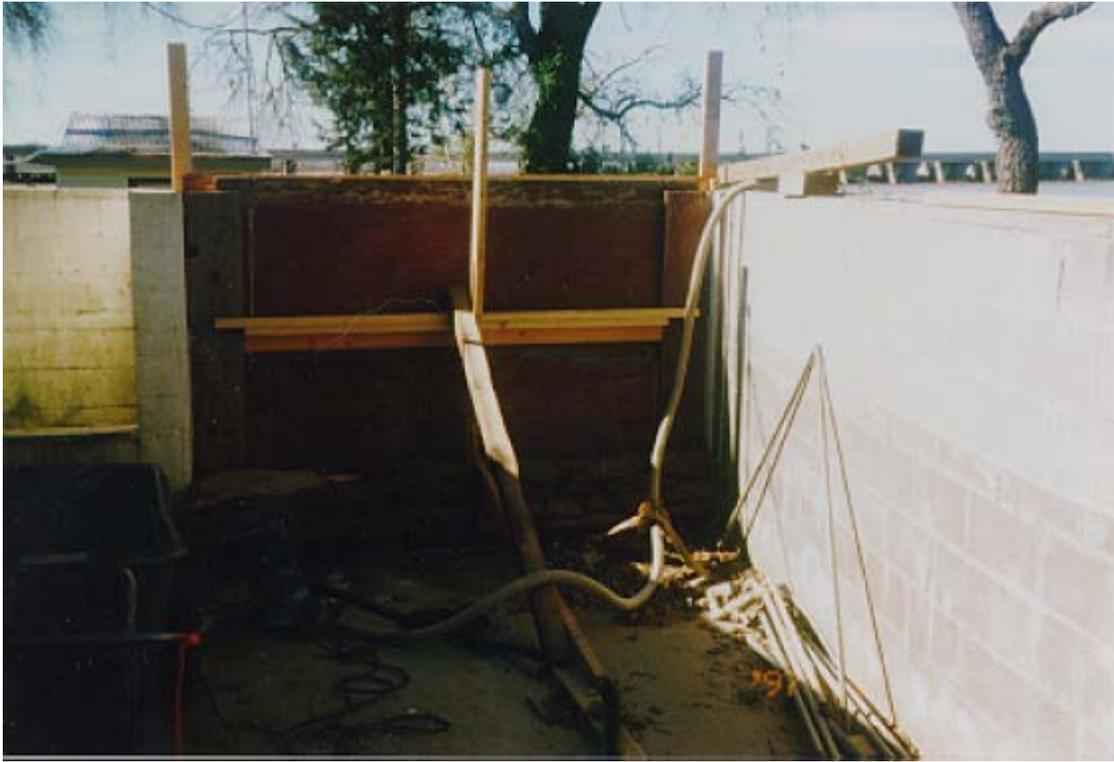
Looking at the largest closure structure and sump pump. Note the electrical cords on the concrete floor.

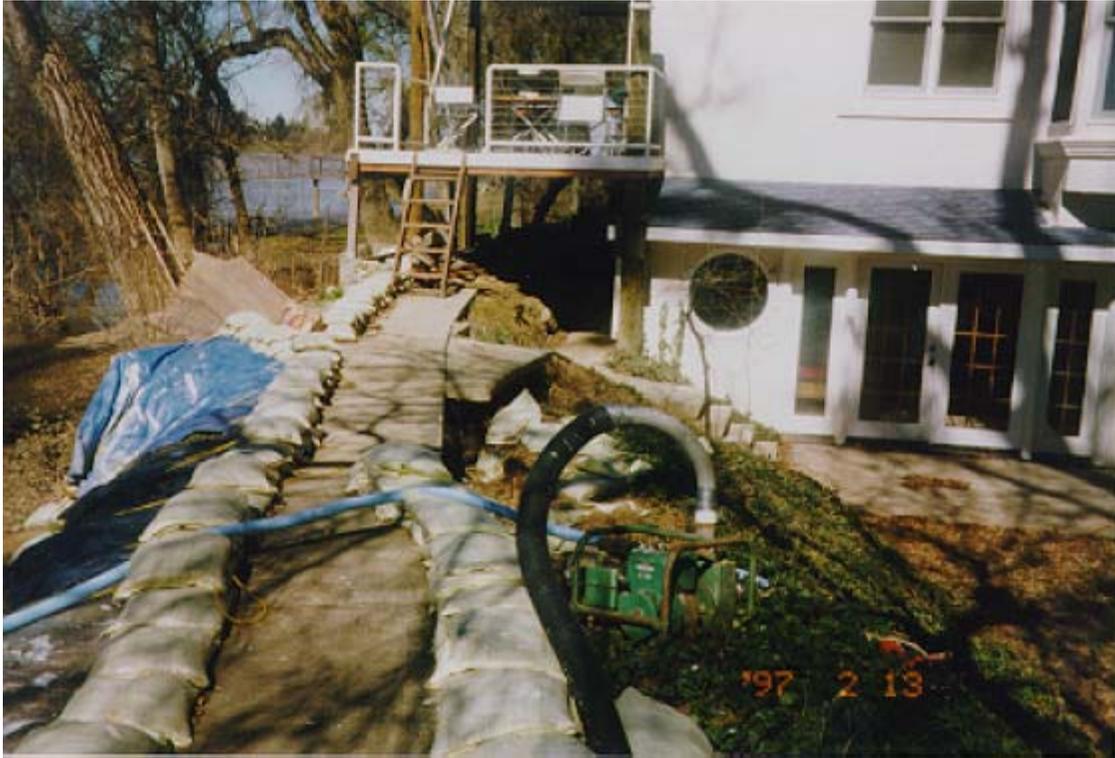
Looking along the overtopped levee. Note the Sacramento River at the left and the low elevation of the developed first floor of the structure relative to the river elevation.

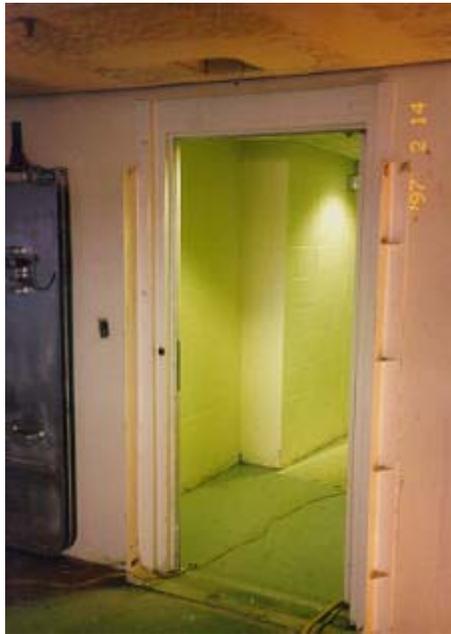
Looking at a doorway into the “protected” area. Note the state-of-the-art pneumatic seal closure at the left in its storage position. Also note the gap between the top of the closure and the top of the doorway.

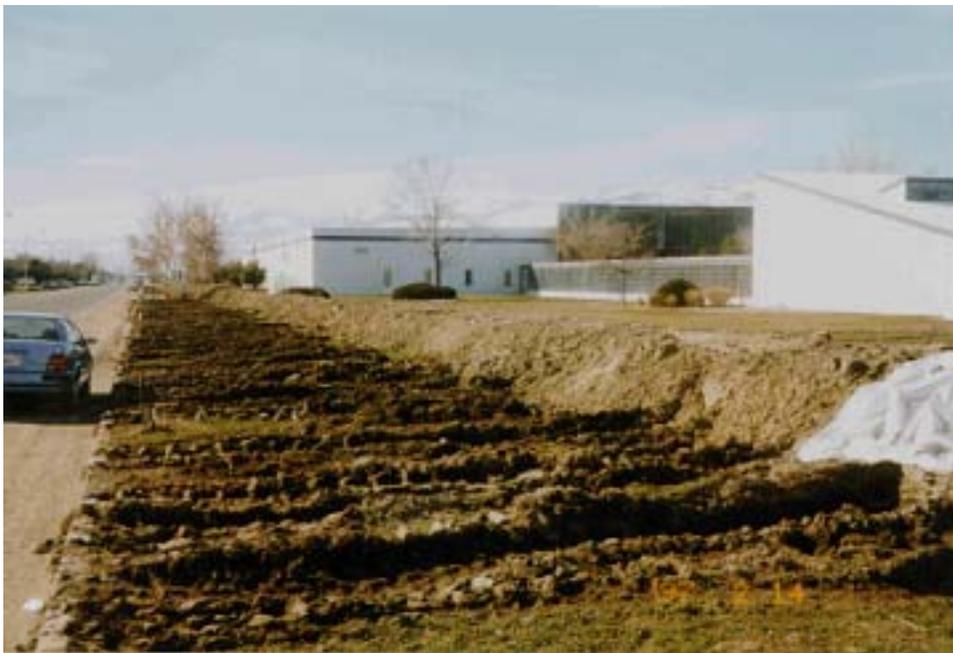
Looking at the recently constructed earthen embankment protecting Structure 95. Note the plastic sheeting at the far right that was placed over the embankment's unprotected side and held in place with sandbags to provide impermeability to the embankment.

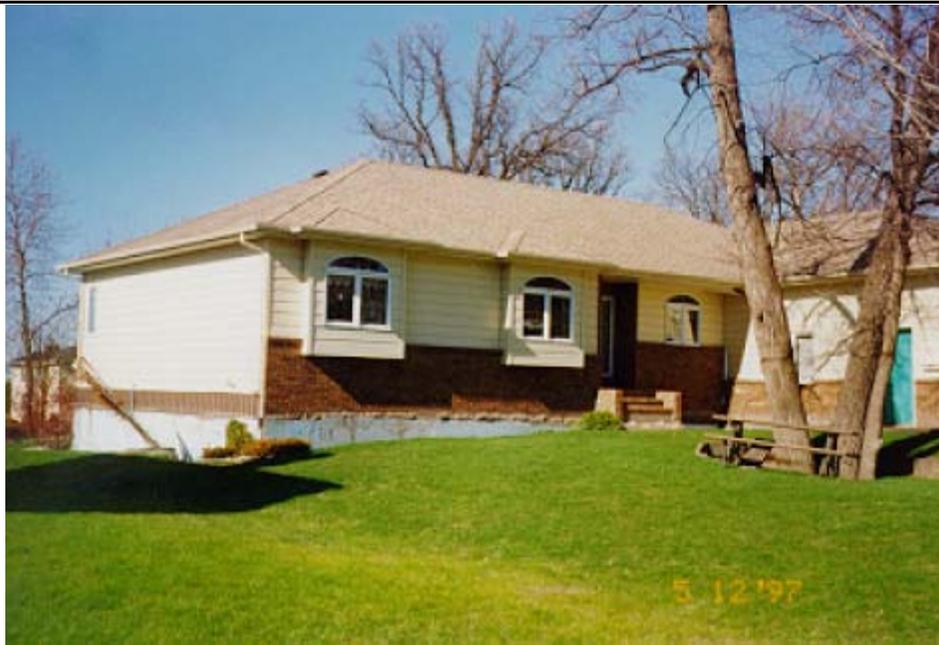
Looking at the structure. Note the garage on the right that held that part of the structure down and the exposed basement wall on the left indicating the amount of lifting that occurred on the west side.
