PREFACE

Considerable information on flood proofing exists. This information is generally in the form of brochures, booklets, or reports describing the various flood proofing measures, where the measures should be used, and how to design flood proofed structures. The U.S. Army Corps of Engineers' National Flood Proofing Committee (NFPC) has recognized the need for information that describes how flood proofing measures perform when they are actually tested by floodwater. The NFPC originally solicited such information from Federal and State agencies and other organizations; however, the request resulted in little information. As a result, the NFPC acquired information by visiting various selected flooded areas across the United States. Flood proofed structures located within those flooded areas were inspected to determine the performance of flood proofing measures. The NFPC documented the results of its information-gathering effort into this report, which describes actual flood proofed structures and how floodwater affected those structures. With each specific case described, a "lesson" is presented to briefly describe what worked and what did not.

Data on 12 floods were collected.

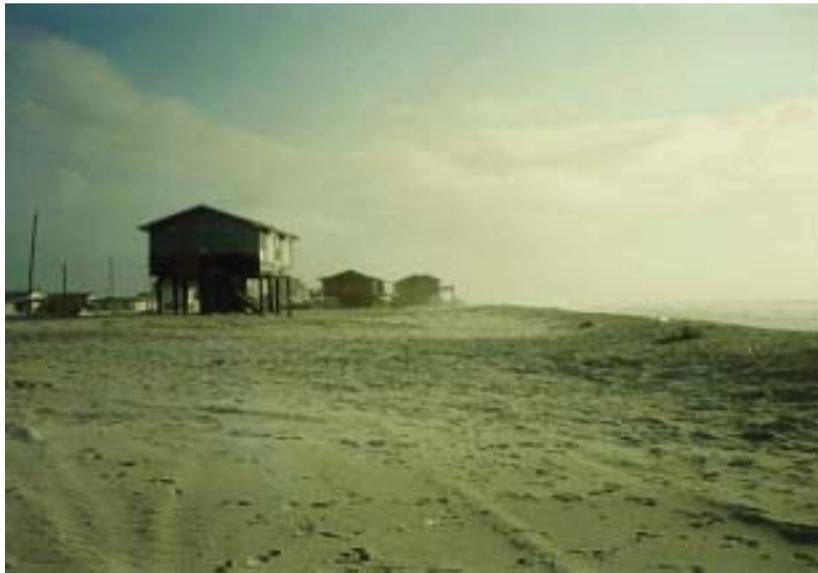
STRUCTURE 86. This structure, which directly fronted the beach, was a one-story, single-family wood-frame home elevated approximately 8 feet on wooden piles. It had an enclosed lower area for storage of utility items. Embedment of the wooden piles was adequate to withstand scour from this event. This structure survived well, as did other structures of this type similarly elevated.

Lesson. This structure survived well in this event. However, the enclosed lower area could have created a problem due to the obstructive effect of the floodwater creating hydrodynamic force against the enclosed area and higher localized velocities as floodwater flowed around the enclosed area. This effect could cause excessive localized scour to depths not anticipated in sand, undermining pile supports and causing failure. It is best in warm climates, such as occurs in Florida, to have lower level storage areas enclosed with “jail-type” spaced bar construction so floodwater can flow through, eliminating hydrodynamic force and scour potential.

Looking along the beach at the structure.

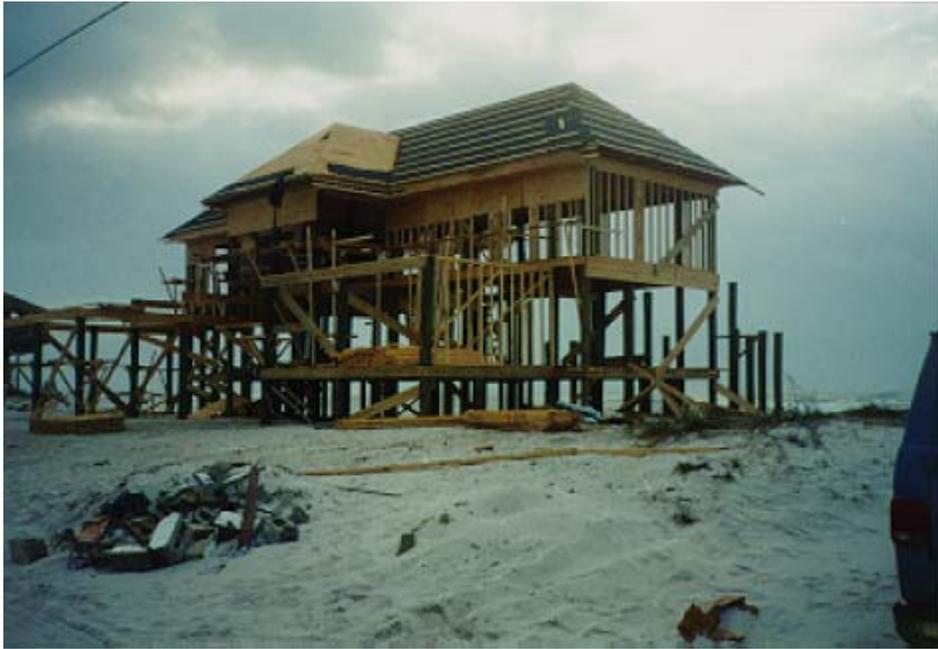
STRUCTURE 87. This was a two-story, single-family residential structure elevated on 12-inch-diameter wooden piles. The piles were of such length that they extended from embedment depth up to the roofline so the entire structure was tied together by means of the wooden piles. Hurricane-type steel fasteners were in place. The first floor was elevated 8 feet above grade, with the lower area entirely unobstructed. The structure was under construction at the time of the event.

Lesson. This structure was designed to accommodate hurricane hazards from wind,

flooding, and scour. One possible weakness was observed at the intersection of the main floor with the wooden piles. The wooden piles were notched to accommodate a resting place for the main floor sills to the extent that the 12-inch-diameter wooden piles were reduced in diameter to approximately 6 inches. This weakens the effectiveness of the piles' ability to bond the entire structure together in terms of the ability to withstand hurricane force winds.

Looking at the structure with the beach in the background.

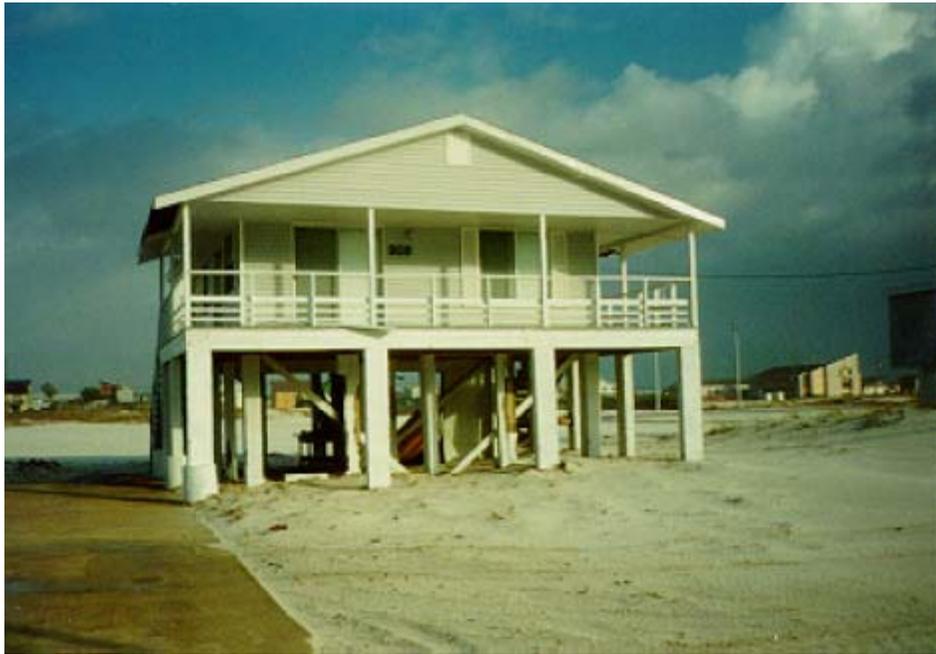
STRUCTURE 88. This structure was a single-family, wood-frame home elevated on columns made of concrete block with a one-half-inch rebar grouted into each hole of the concrete block. This made a reinforced concrete block column for use in elevating the structure about 8 feet above grade. The structure was about 300 feet from the beach on the landward side of a beachfront street. The structure survived the event well, except for the reinforced concrete block columns, which sustained severe cracking apparently from the torsion effect of the hurricane force wind against the structure. No “x” bracing was used between the columns. The columns appeared to be close to failure.

Lesson. Reinforced concrete block columns of this design are not appropriate in coastal areas where high wind forces occur against a structure. The concrete block columns should have contained more rebar in order to provide rigid strength against the hurricane force winds. The best alternative is to use piles that have the ability to resist this type of force without becoming damaged.

Looking at the structure.

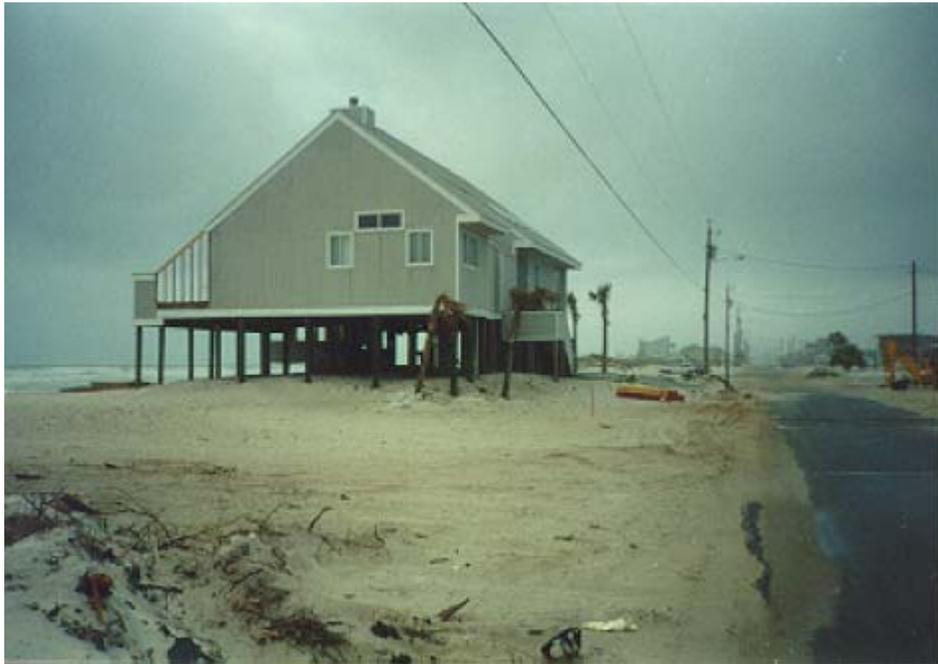
STRUCTURE 89. This structure was a new, one-story, single-family home elevated on wood piles. It directly fronted the beach. The structure employed proper elevation, wood piles for support, proper pile embedment depth, minimal floodwater obstruction, and proper wind proofing. The structure received minimal damage during the event. It was the only structure in the reach that survived.

Lesson. This structure survived the event well because it incorporated proper design and construction to withstand hurricane force winds, flooding, and hydrodynamic force associated with such a storm.

Looking at the structure. Note the beach at the left. Note also the absence of adjacent structures, which had been destroyed and removed.

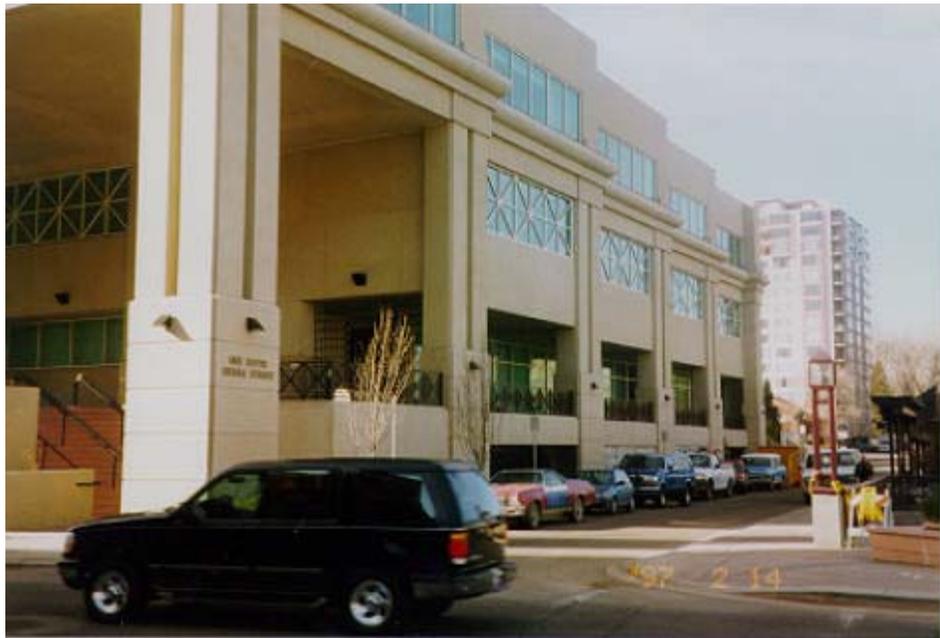
STRUCTURE 92. This structure was a multistory public building located within about 100 feet of the Truckee River. The building was constructed in 1996. The building walls were constructed of reinforced concrete. Ample warning time prior to flooding was present. The lower level was flood proofed by wet and dry flood proofing. The wet flood proofed area was used for building access and vehicle parking. The remainder of the lower level was dry flood proofed by using waterproofed reinforced concrete with a state-of-the-art closure panel consisting of metal construction with a pneumatic seal on all sides except the top, which left a gap in all closures of about 8 inches.

Lesson. The wet flood proofing measure functioned properly, with apparently little damage in this part of the lower level. The dry flood proofing measure however, failed. This measure was designed for 1 foot above the 100-year flood. The flood event of January 1997 exceeded that level. Floodwater overtopped the closure panel completely, inundating the protected area. Obviously, the closure panels and the reinforced concrete walls should have been designed for a higher level of flooding that would have completely closed all openings. The state-of-the-art metal panels with a pneumatic seal functioned as designed without damage. They were simply not high enough. In addition, it was reported that floodwater was already about 1 foot deep in the protected area before floodwater overtopped the closure panels, indicating water was leaking through the waterproofed reinforced concrete. The most reliable waterproofing method for reinforced concrete is to “sandwich” a nonpermeable membrane between the layers of concrete. No damage was apparent to the actual reinforced concrete wall due to hydrostatic force.

Looking at the structure. The Truckee River is immediately to the right.
The flood proofed floor is at the automobile level.

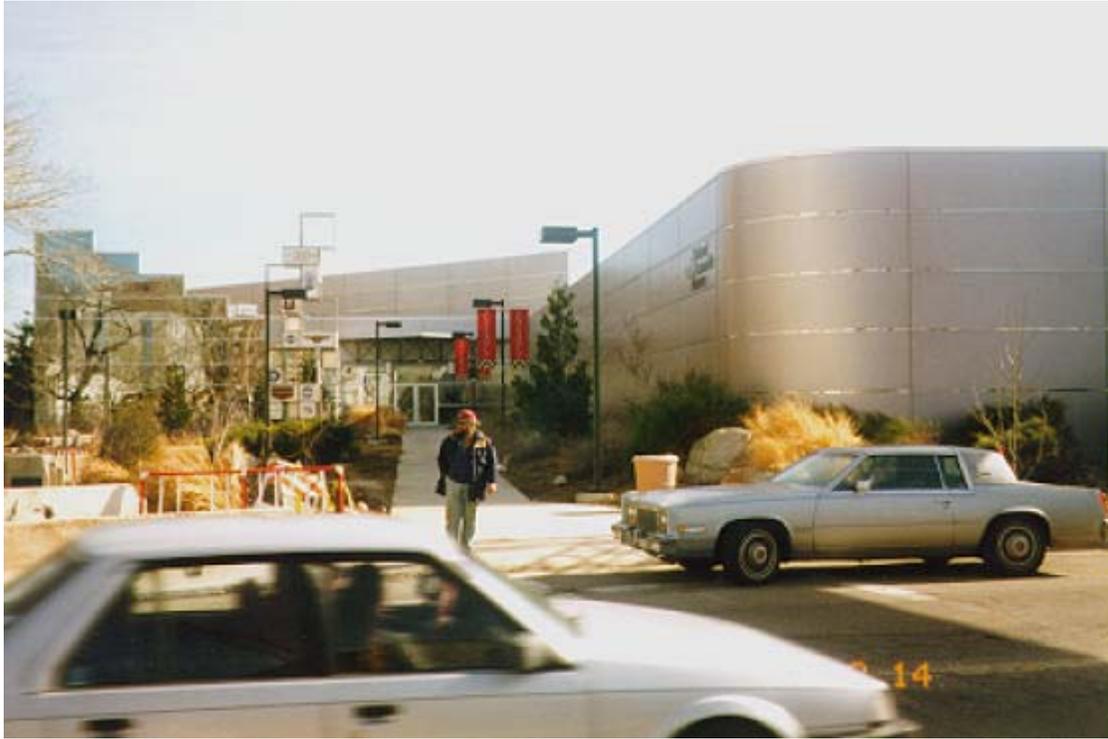
STRUCTURE 93. This structure was a single-story, slab-on-grade building located about 50 feet from the Truckee River. It was built in 1989 just downstream from a city bridge over the river. It was flood proofed by elevation on fill to a level 2 feet above the 100-year flood. A flood fight was waged with sandbags and plastic sheeting at openings on the upstream side of the building. The downstream side of the building was higher than the floodwater.

Lesson. This structure and its contents had minimal damage due to the flood proofing measure of elevation on fill and the flood fight. The lesson for this structure consists of four parts. First, the flood proofing measure enabled a flood fight to be successful. Second, a decision had to be made based on upstream flood information that a successful flood fight was possible while still keeping safety in mind for the flood fight personnel (since a basic parameter of flood proofing is to evacuate). Third, the impact of debris in the upstream bridge needed to be considered. This was evidently overlooked when the flood proofing elevation was selected. In the flood event, the upstream side of the bridge filled with debris to the extent that floodwater was forced out of the channel and onto the street just upstream from the structure at an elevation higher than the computed water surface elevation for a flood of this magnitude without the obstructive effect of the bridge. The fourth part of the lesson concerns the value of the contents in the structure. The contents consisted of \$25 million worth of nonreplaceable antique automobiles. Contents that are nonreplaceable should always be located in a flood-free location.

Looking from the upstream street downstream at the structure.
The doors in the background are one of the flood fight locations.

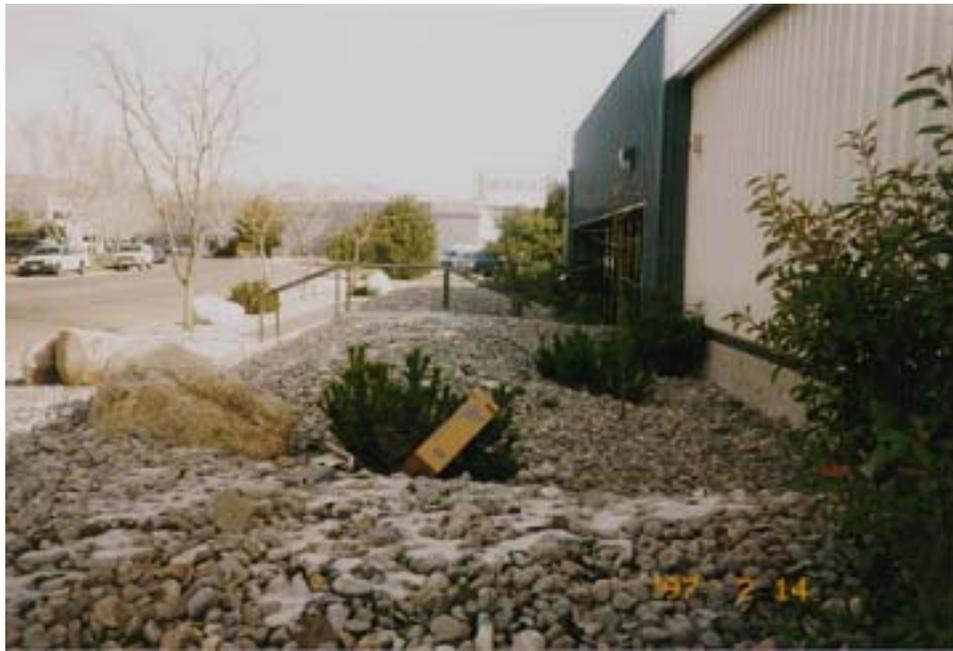
STRUCTURES 94, 95. These structures were both slab-on-grade commercial buildings located several hundred feet from the Truckee River. The area was subject to only shallow flooding. These structures are presented to illustrate a type of earthen embankment that can be very effective in flood proofing against relatively shallow, short- duration floods. Structure 94 had been landscaped well to blend into the surroundings and be aesthetically pleasing. This embankment was a permanent flood proofing measure. The embankment protecting Structure 95 had just been constructed. It could be removed after the flood event or remain as a permanent measure. Sandbag closures across vehicle access routes were necessary.

Lesson. These flood proofing measures were successful. Earthen embankments, especially in shallow-depth flood areas of short duration, can be quite effective if placed on a permanent or temporary basis. Obviously, all parts of an earthen embankment flood proofing measure such as interior drainage, closures, and so forth must be present and functional.

Looking along the earthen embankment with Structure 94 on the right. Note the raised handrail as the pedestrian entry to the building passes over the embankment.

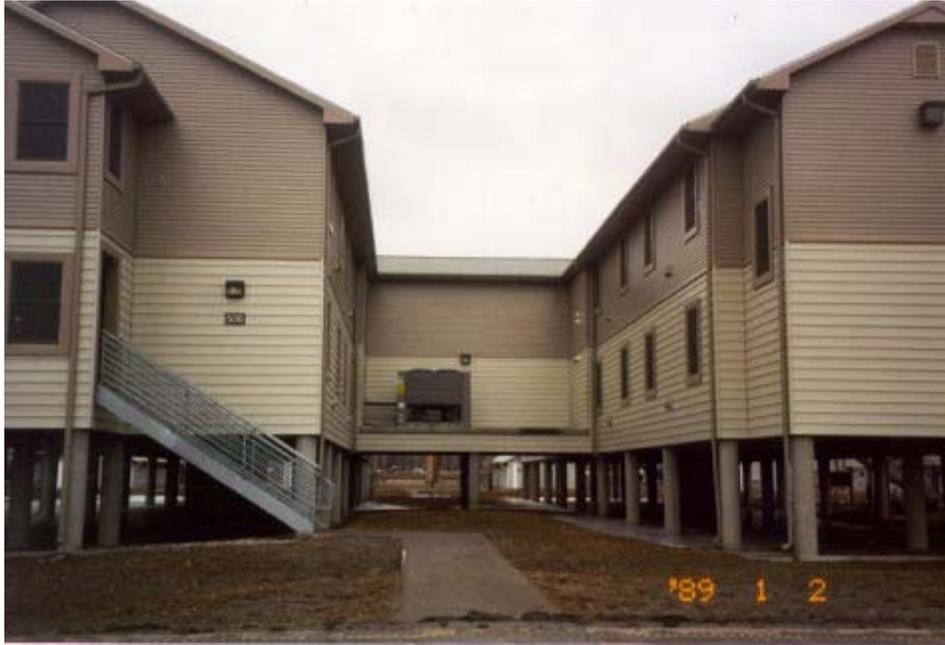
During the 1997 flood event, about 3 feet of floodwater inundated the area beneath the elevated buildings. Massive ice blocks also floated beneath the elevated buildings, directly impinging upon the posts. Floodflow velocity was moderate. No damage occurred due to either floodwater or the impact of the ice blocks.

Lesson. This flood proofing system performed very well in this flood event. The buildings were elevated enough to be above the flood elevation and the posts were strong enough to withstand the impact of floating ice blocks without damage. Erosion was not a factor for the event.

Looking at one of the elevated buildings.

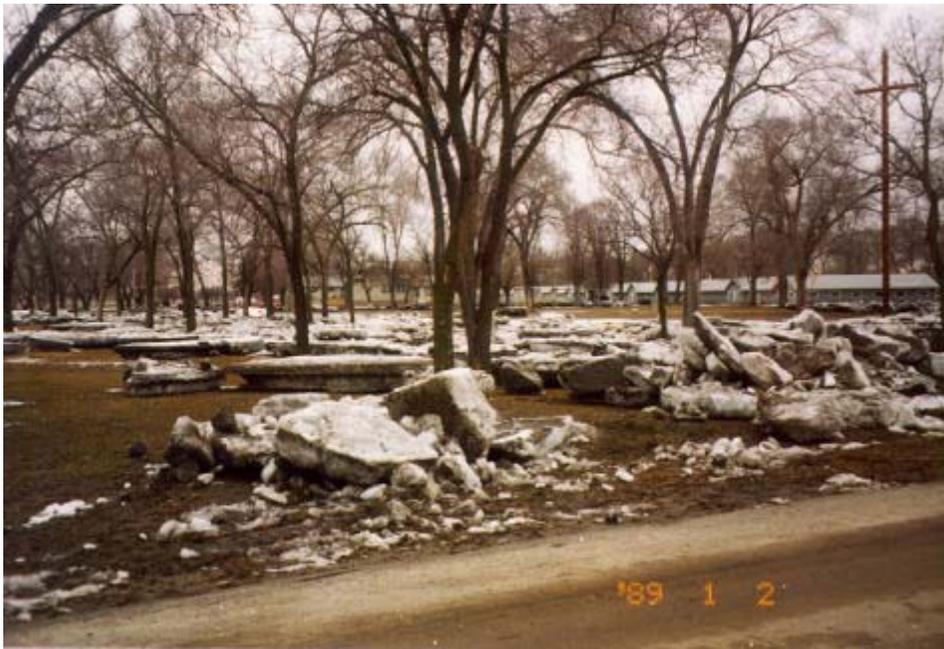
Looking at the massive ice blocks that passed through the area.
